The Dalles Fish Water Units 1 & 2

The Dalles Fish Water Turbines Phase 1A Report

Draft Final Report

May 2018

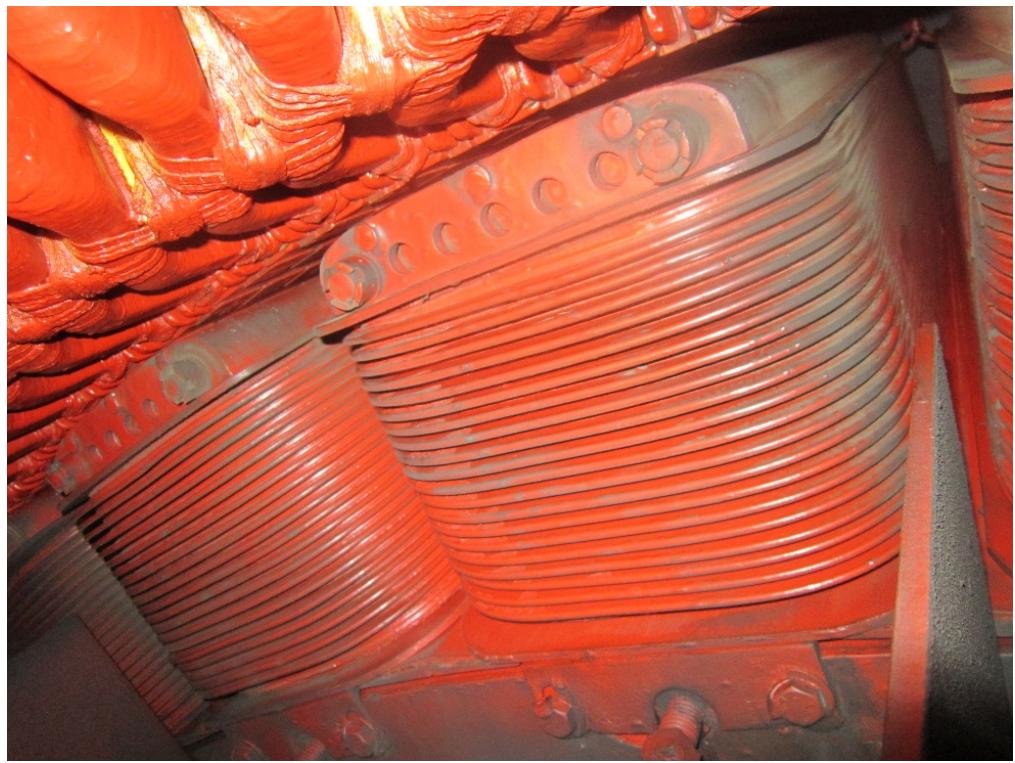
Photo E. Unit 2 Rotor Poles

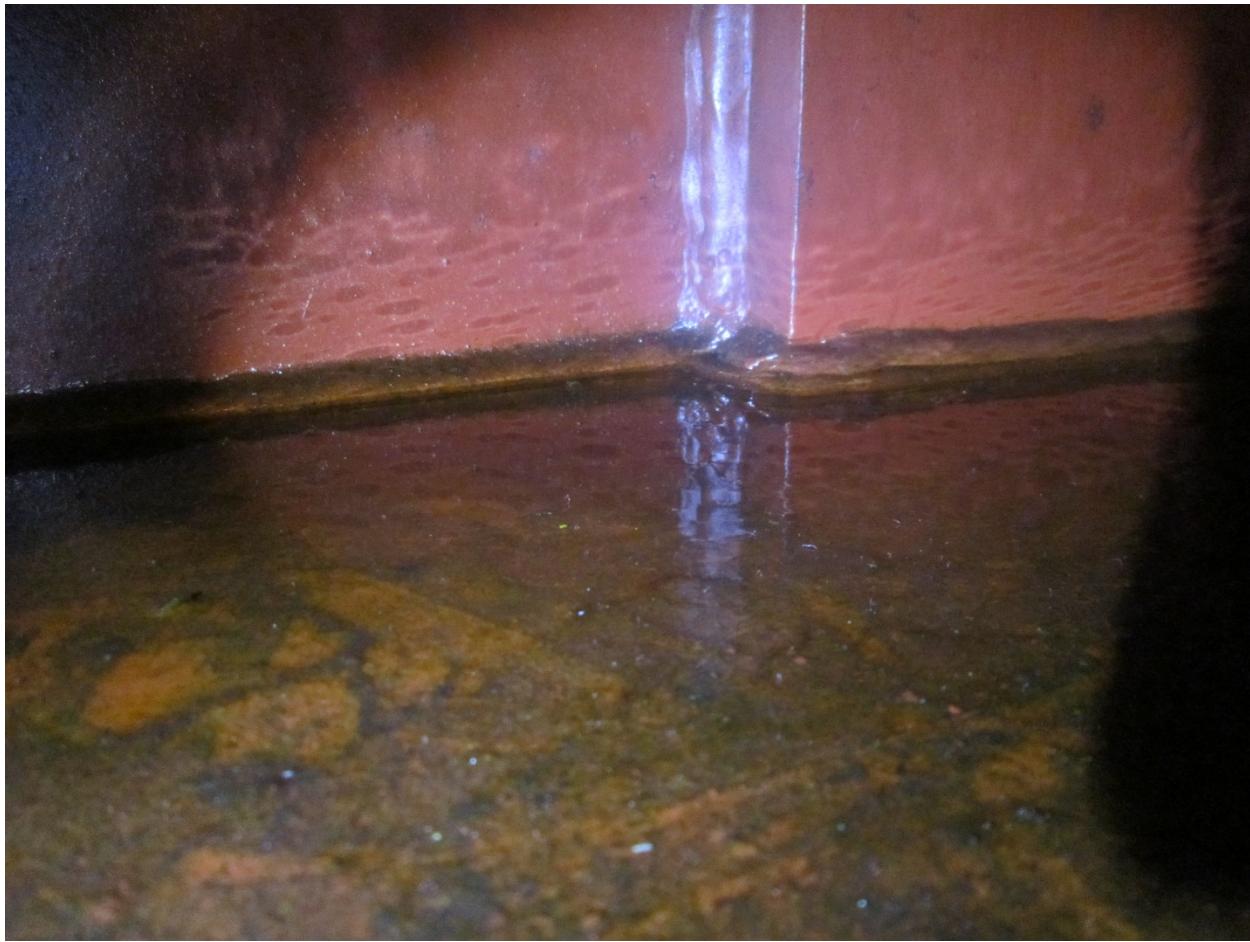
Photo G. Oil Found on the bottom of Unit 2 Generator Frame

Oil was seen on the bottom of the generator stator frame. I was not known where the oil came from or how it got here. However it did not appear that oil got on the winding or core. It is recommended that the oil be cleaned. Project has cleaned the oil since then.

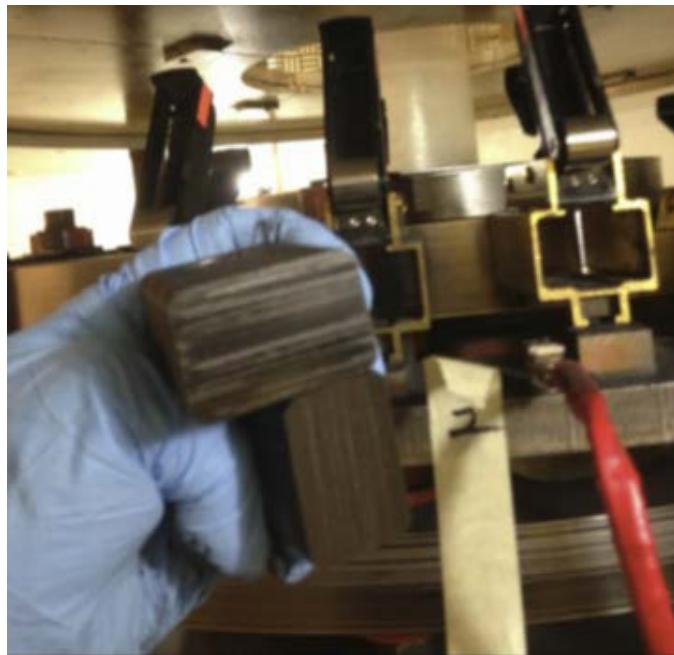
The Dalles Maintenance staff noticed excessive brush wear for The Dalles Fish Units since at least 2011. Staff engaged The Dalles engineering, HDC, and Helwig, the brush manufacturer, in troubleshooting and developing a solution. Wear issues are still unresolved, as wear is considered excessive for less than two years of operation. The brushes as of the last check in 2015 is approximately one year old.

Photo H. Brush Threading and Uneven Wear

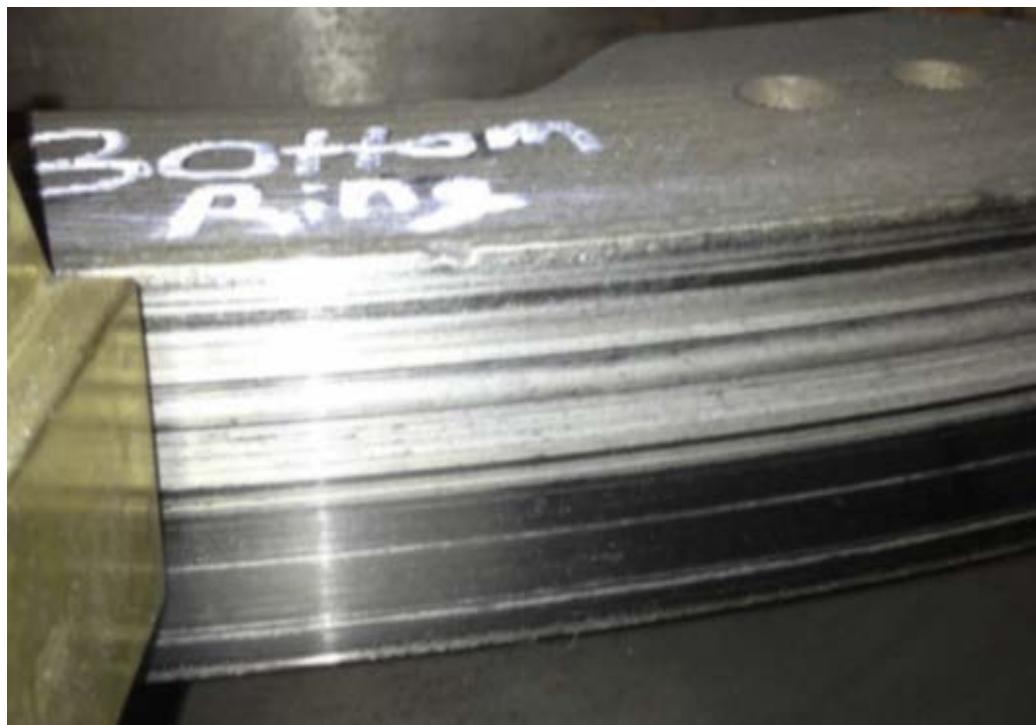
Photo I. Typical Film and Streaking

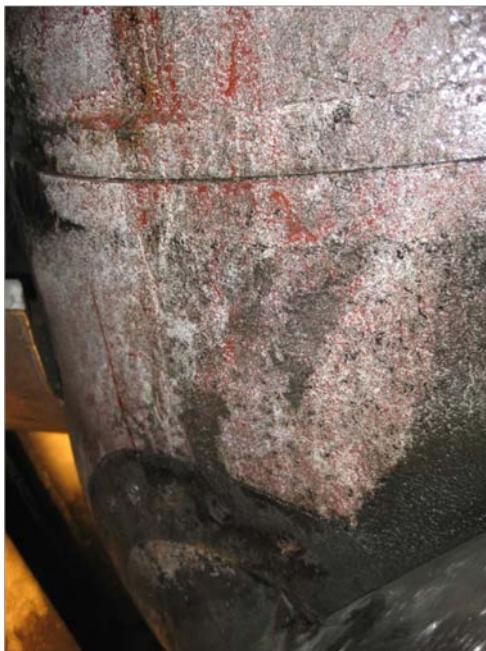
Figure 7. Stainless Steel Overlay on the Blades Suction Side (Underside, Leading Edge)

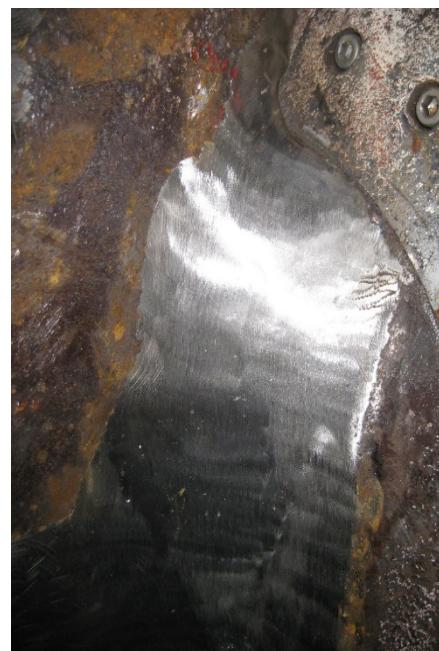
Figure 8. Paint Still Visible on the Runner Hub

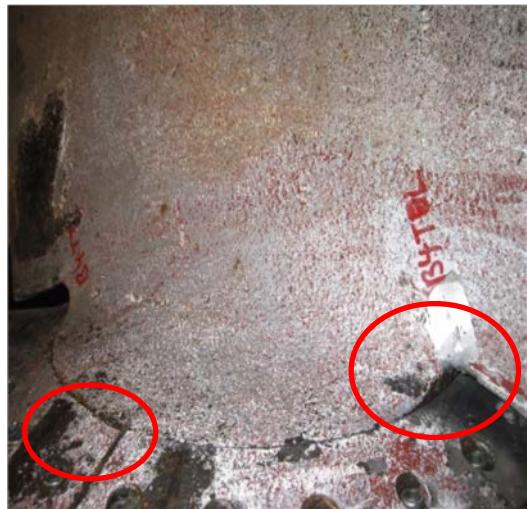
Figure 9. Blade Cracks That Have Been Repaired and Are Not Re-Cracking

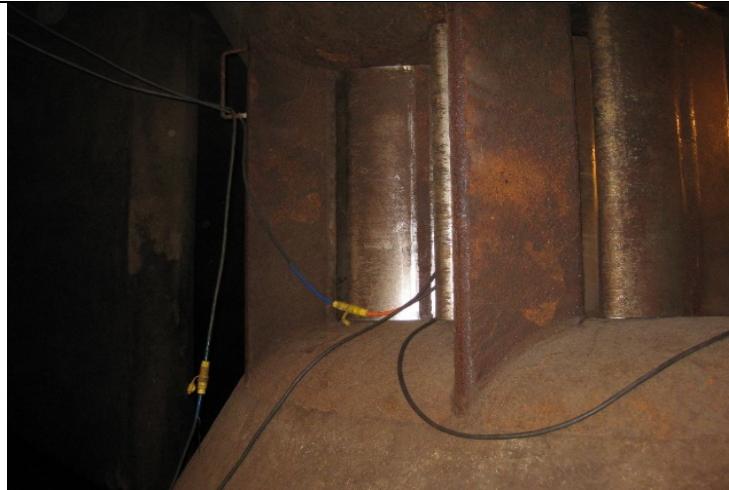
Figure 10. Wicket Gates and Stay Vane in Good Condition

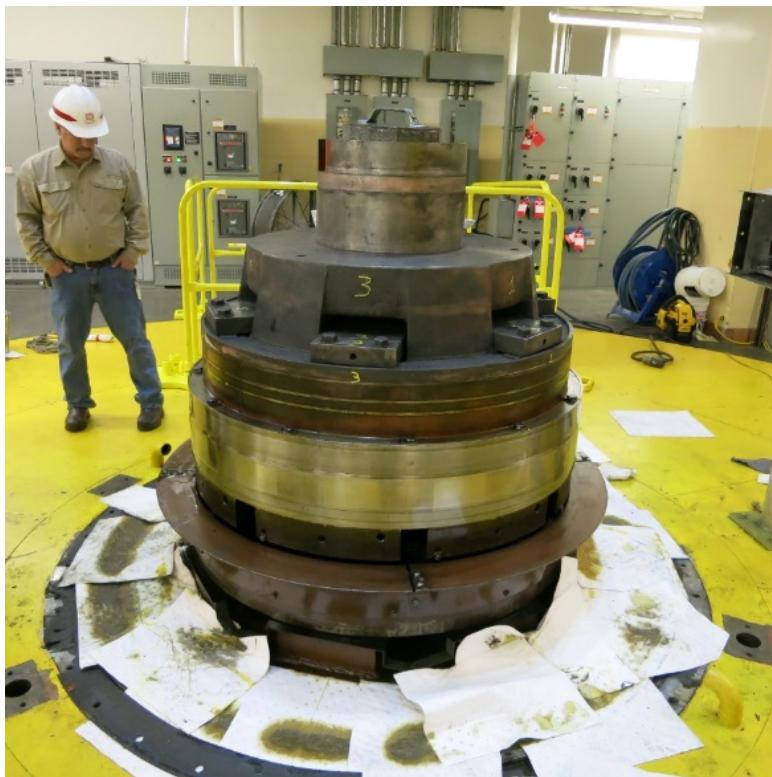
Figure 13. Unit 2 Disassembled Showing the Combination Generator Thrust Bearing/Upper Guide Bearing

bearing. The Dalles has a spare Thrust bearing runner and shoes. The thrust bearing/upper guide bearing combination shown in the photo was disassembled in December 2015 due to an oil overheating problem in the bearing tub. The bearing shoes were hand scraped and the oil changed. When the unit was reassembled the overheating issue stopped.

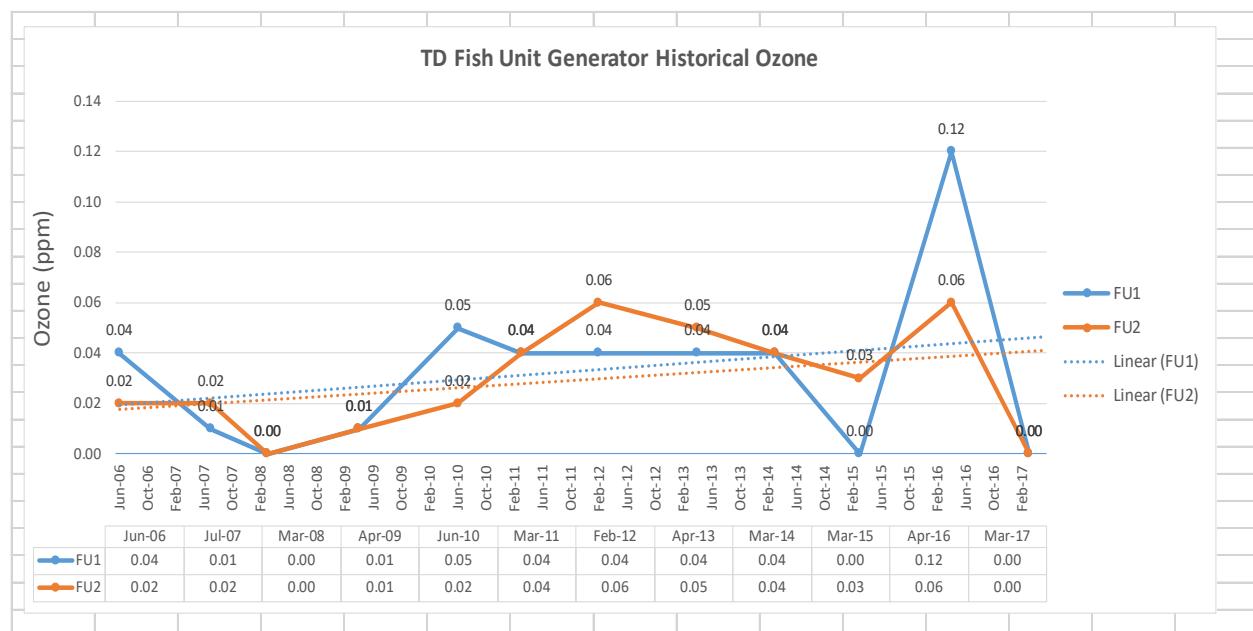
Figure 22. Ozone Data

With the exception of June 2016 measurement on unit 2 (0.12 ppm), the level in both units were found acceptable. The ozone level appears trending upward. This is an indication of more slot discharge activities.

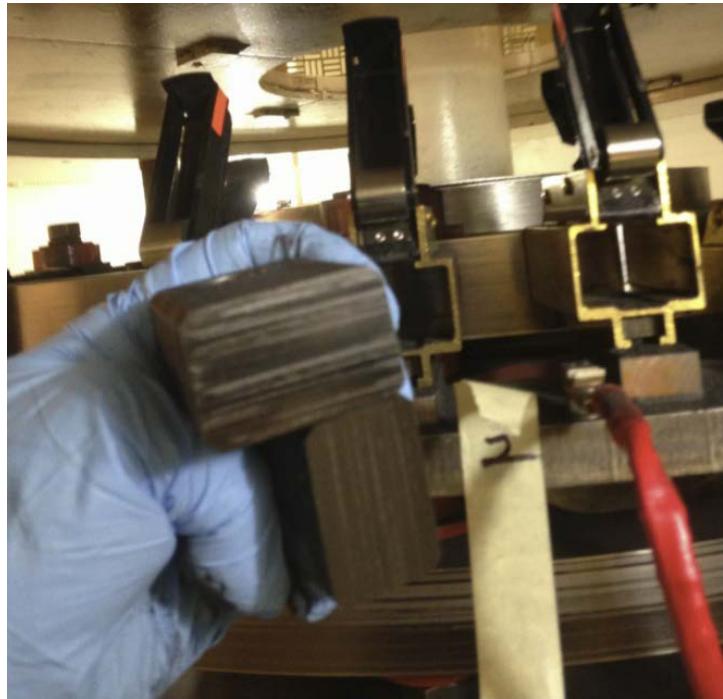
Photo 1: Brush threading and uneven wear

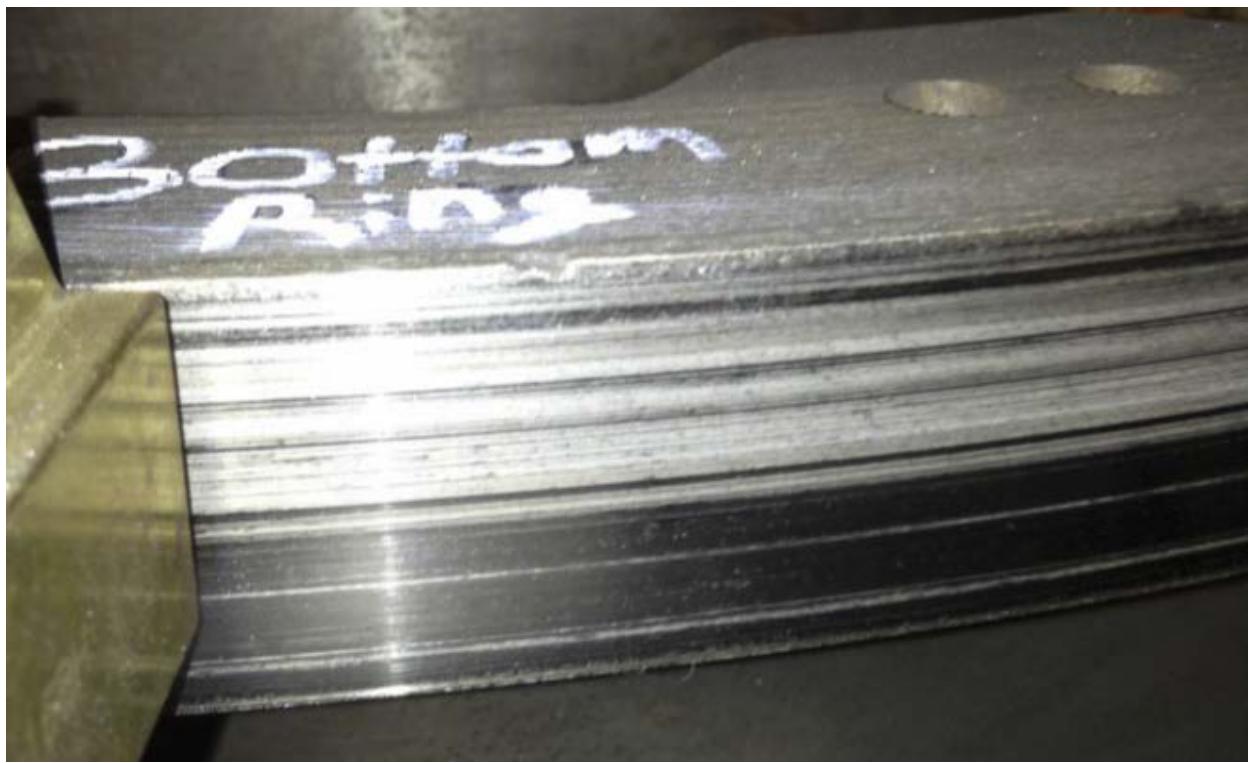
Photo 2: Film and streaking

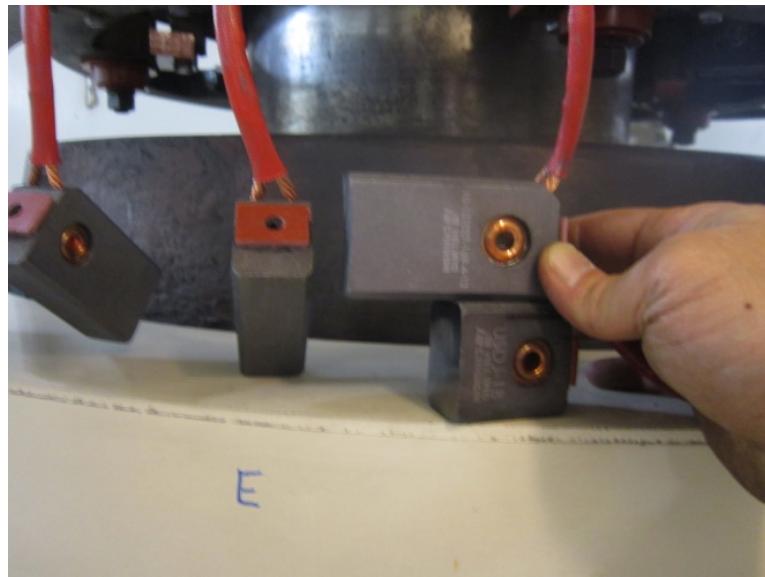
Fish Unit 1							
Brush Type	H552						
Current, Amperes at 14 MW load	Position	1	2	3	4	5	6
	Top Ring	57	57	60	62	80	Removed
	Bottom Ring	57	59	66	56	84	Removed

Photo 3: Generator Brushes

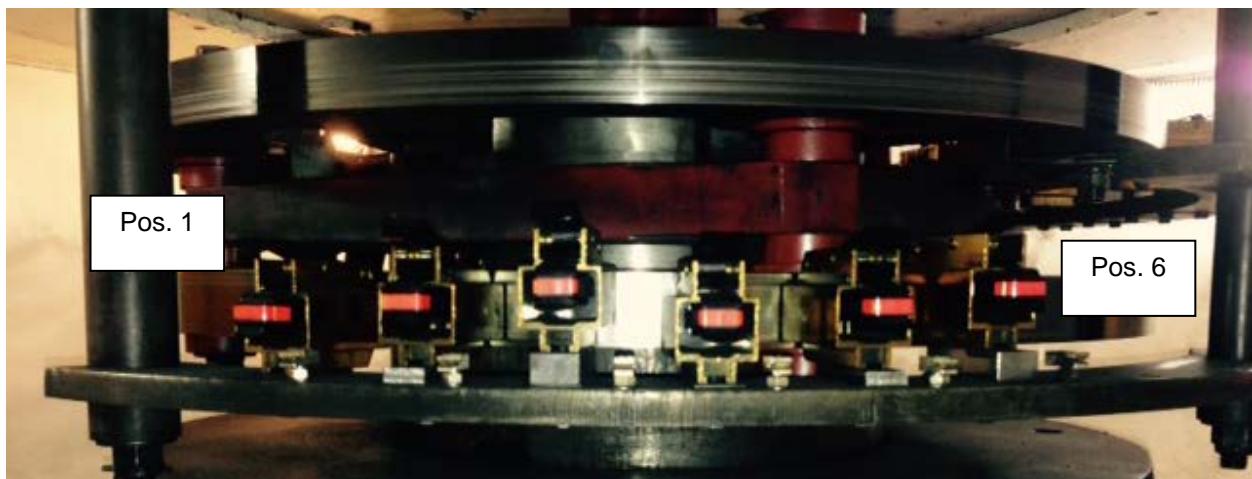
Initial discussion focused on removing the second brush as originally proposed. Also considered was switching to a composite grade electrographite brush. During these discussions it was also proposed that the differential brush height with the removed brush position 6 could lead to a poor conductive film deposition for the corresponding height brush – brush 3 – relative to the remaining brushes as shown in photo 3.

Photo 4: Brush height distribution
