MEMORANDUM FOR THE RECORD 19 LGS 09 Doble Outage Modification and ESBS Problems**SUBJECT: Little Goose Doble Outage Modification and ESBS Problems**Background

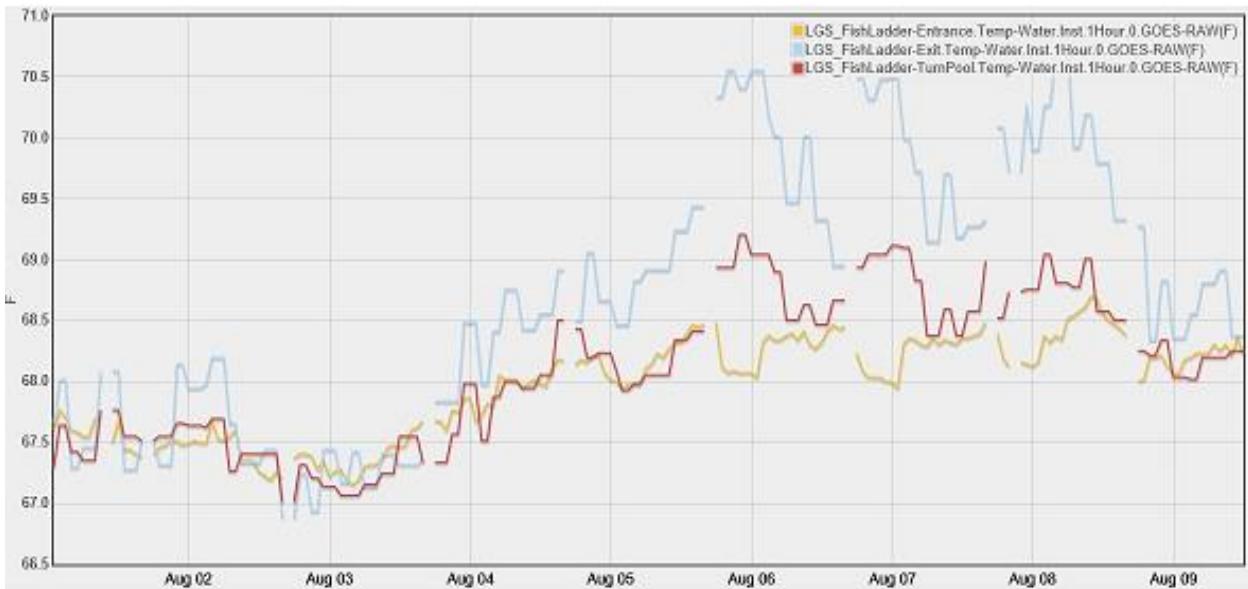
Figure 1: Little Goose Dam adult ladder temperature; August 1 through August 9, 2019.

Unit priority was changed from 1, 2, 3, 4, 6 to just unit 6 operating at “speed no load” from August 05 at 08:27 through August 08 at 16:52 during daytime hours. In addition, the fish ladder cooling pump was out of service from August 05 at 04:40 through August 08 at 17:30. Changes in unit priority and fish ladder temperature differentials may increase passage delays,

however, the daily adult counts during the outage were within the variability in daily passage numbers before and after the outage.
