MEMORANDUM FOR THE RECORD 20 LGS 05 Unit Priority**SUBJECT: Little Goose Unit Priority**Background

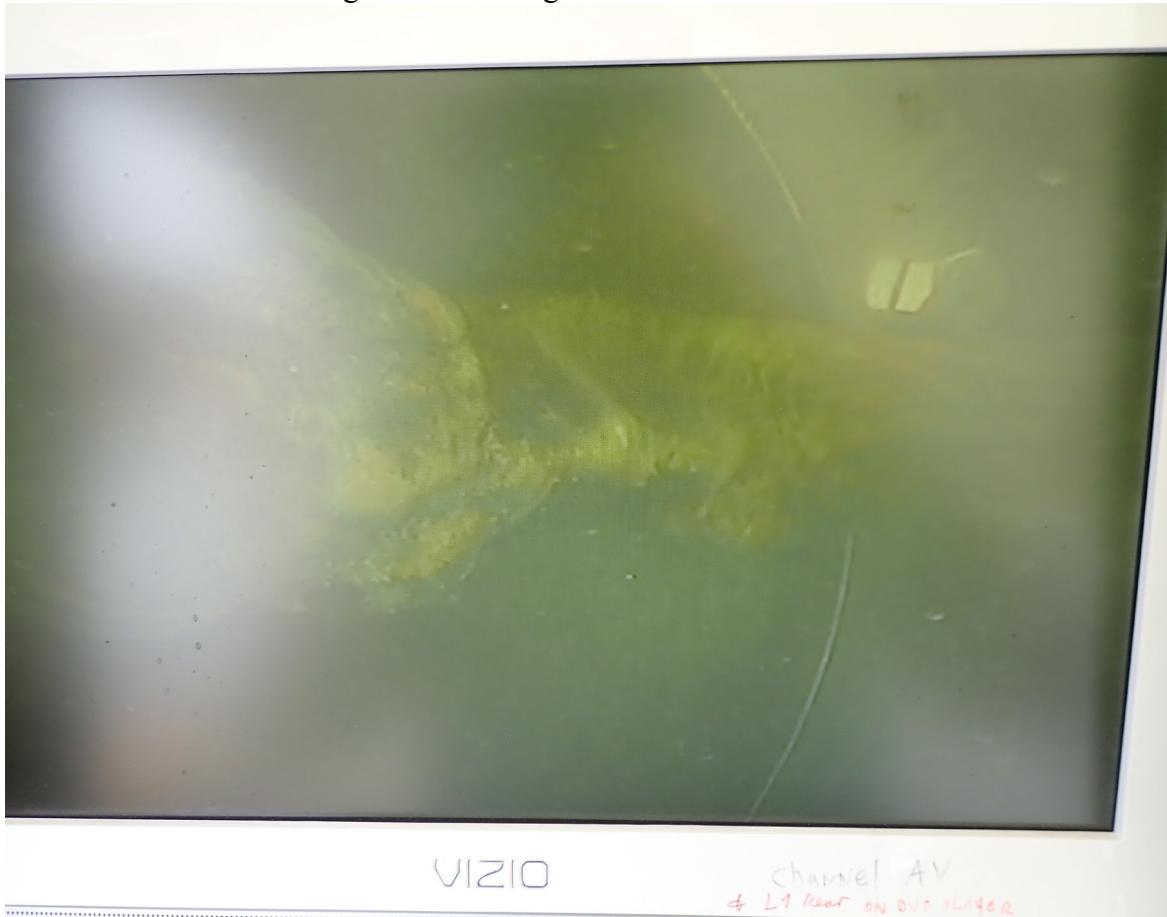
Little Goose Juvenile Fish Facility (JFF) staff noticed an abnormal flow in orifice 1A2 during routine checks the morning of May 5. JFF staff worked with Little Goose operations staff as well as District staff to strategize a path forward.

Picture 1: Underwater image of debris lodged in orifice 1A2.

Little Goose forced Unit 1 out of service immediately after performance standard spill in order to utilize an underwater camera to troubleshoot orifice 1A2 (Table 1). Unit 2, the next Unit in priority, was operated during in accordance to the Fish Passage Plan (FPP, Chapter 8, Table LGS-5). JFF staff found a large piece of woody debris lodged in the orifice (Picture 1 & 2). Debris was removed from the orifice and the Unit was returned to service.

Little Goose will continue to conduct routine inspections and utilize all necessary tools to ensure safe passage of juvenile fish through the collection and bypass system. Staff will also continue to monitor debris in the immediate forebay.

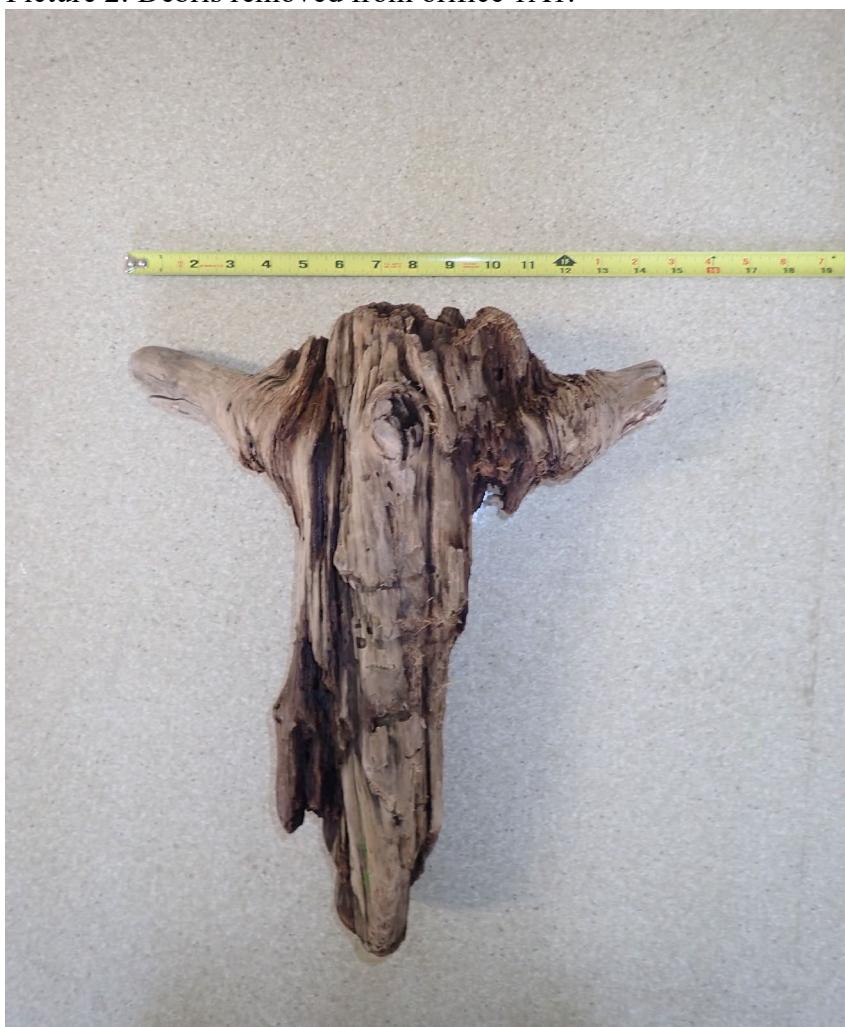
Picture 2: Debris removed from orifice 1A1.
