**MEMORANDUM FOR THE RECORD: 23 LGS 05: Unit Priority Deviation, Unit 5 Roof Top Hatch Repair****SUBJECT: Temporary Priority Unit Deviation for Emergency Removal and Repair of Roof Vent Cover**Background

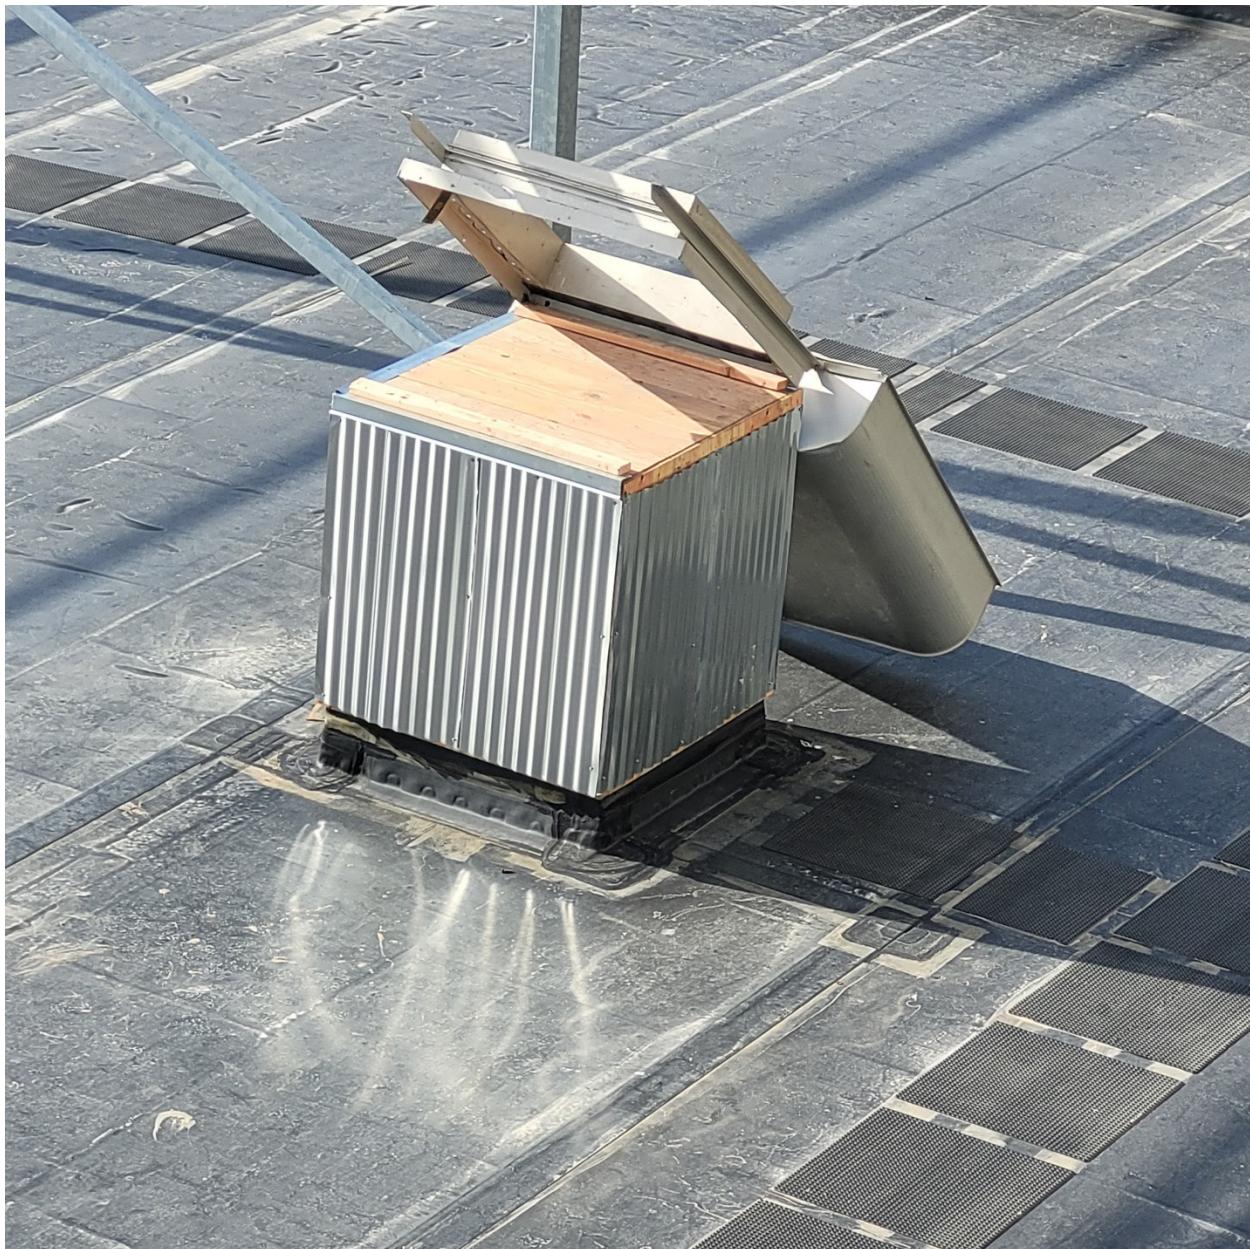
A damaged roof top vent cover or “doghouse” was discovered the morning of April 13, 2023. Presumably resulting from wind damage, the unit was found knocked out of position and risked coming completely loose. The cover lodged at an angle that posed a serious threat of intrusion into the interference zone of the 500kV BUS work, presenting a significant safety hazard. An emergency full line outage was immediately coordinated in order to remove the errant doghouse cover and avoid catastrophic system failure.
