**U.S. ARMY CORPS OF ENGINEERS
WALLA WALLA DISTRICT
FISH FACILITIES WEEKLY REPORT
#41-2024**

Dates: December 6-12, 2024

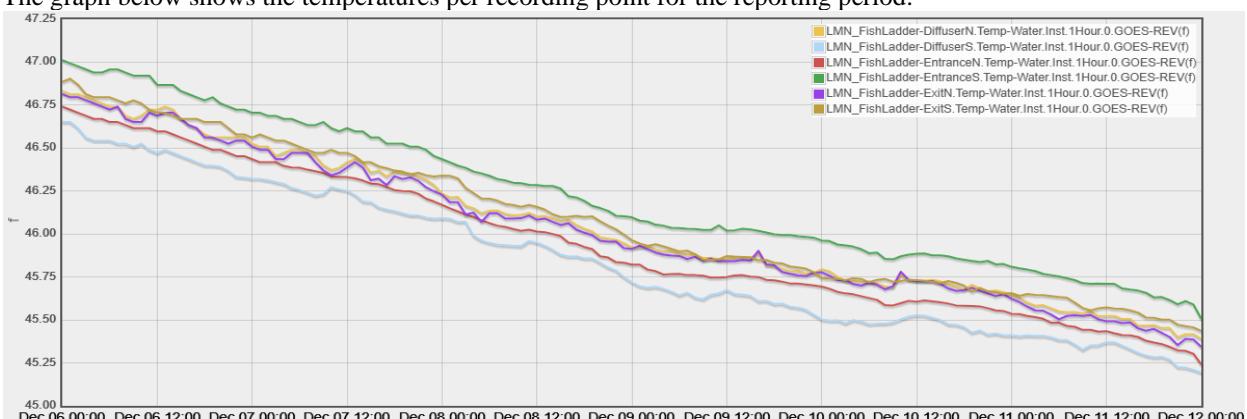
Temperature Probes: The adult passage temperature probes operated correctly during this reporting period.

The graph below shows the temperatures per recording point for the reporting period.
