**U.S. ARMY CORPS OF ENGINEERS  
WALLA WALLA DISTRICT  
FISH FACILITIES WEEKLY REPORT  
#43-2024**

**Project: McNary**

Dates: December 20-26, 2024

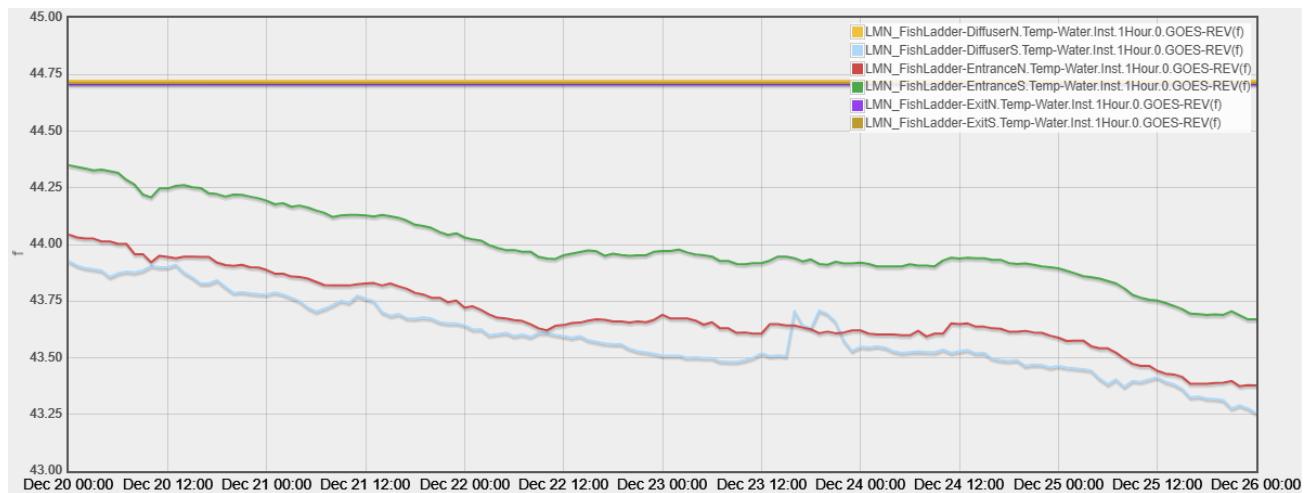
Temperature Probes: The adult passage temperature probes operated correctly except for the north and south exit probes. Hydrology has been notified and will come out to examine them after the holidays, during the second week in January.

The graph below shows the temperatures per recording point for the reporting period.
