MEMORANDUM FOR THE RECORD: 25 LGS 01 JBS Channel Adult Mortality**SUBJECT: Solitary Steelhead Mortality**Background

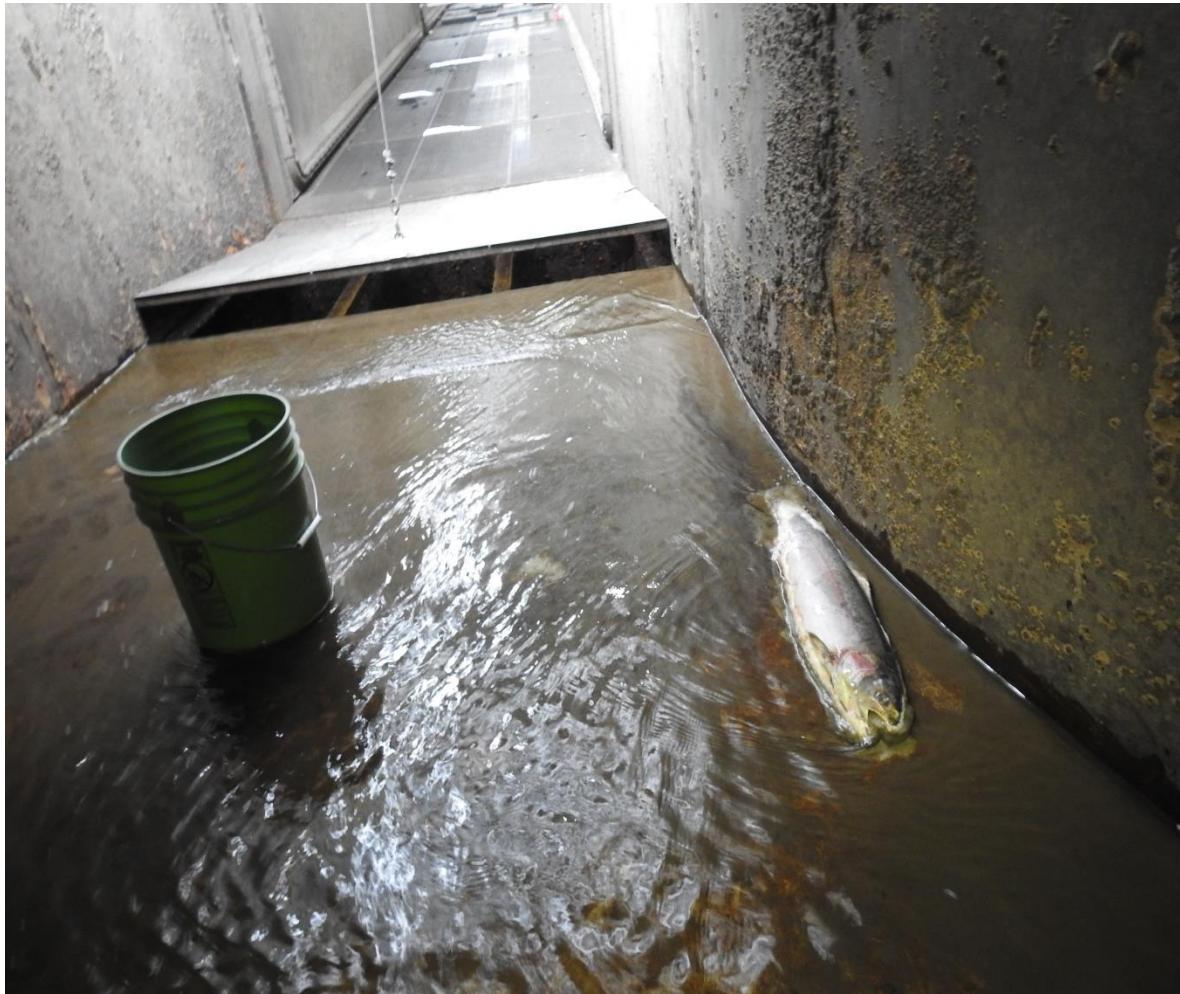
One unclipped Steelhead mortality was observed on the dewatered floor of the Juvenile Bypass System (JBS) channel approximately 3 feet in front of the emergency exit release hatch on January 30, 2025. Juvenile Fish Facility personnel spotted the fish upon executing winter maintenance activities at the primary dewaterer. Maintenance personnel also performed winter maintenance activity in the same area on January 13, 2025, at which time no fish were present on the JBS channel floor. The JBS channel was completely checked and clear of all aquatic species the afternoon of December 18, 2024 and again on December 18, 2024. The mortality incident likely occurred shortly after the January 13, 2025 maintenance activities. The area has no historical record of similar occurrence for at least 10 years.

JBS channel to emergency bypass release pipe; fish mortality location

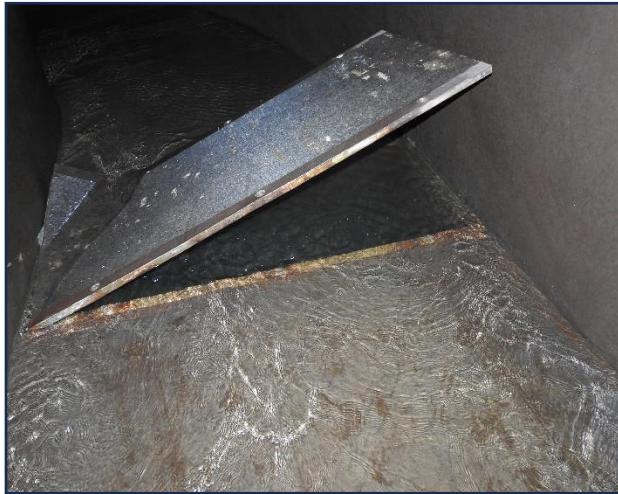
JBS makeup water valve damaged grate cover

- D. Marks and tags – None.
- E. Marks and Injuries found on carcass – None.
- F. Cause and Time of Death – Hypoxia. Estimated time of death shortly after January 13, 2025, based upon degree of fungal presence and tissue decomposition.
- G. Future and Preventative Measures – Investigation discovered the underside of the damaged makeup water grate cover was completely plugged by river vegetation, corbicula shells, and small woody debris as a likely contributing factor to the cover failure. Either an annual or semi-annual periodic maintenance schedule will be proposed to project maintenance personnel following each annual JBS dewatering / decommissioning activity to clear the makeup water grate cover for maximum functionality.

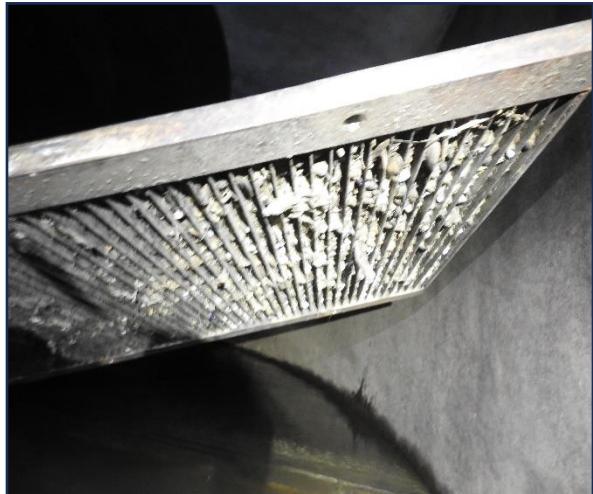
JBS makeup water valve grate underside
