ERDC Spill Pattern Updates
Bonneville, The Dalles and Lower Monumental
Week of September 17th, 2017

ERDC Spill Pattern Updates
 The Dalles Dam
 Week of July 17th, 2017

ERDC Spill Pattern Updates

Week of July 10th, 2017 and July 17th, 2017

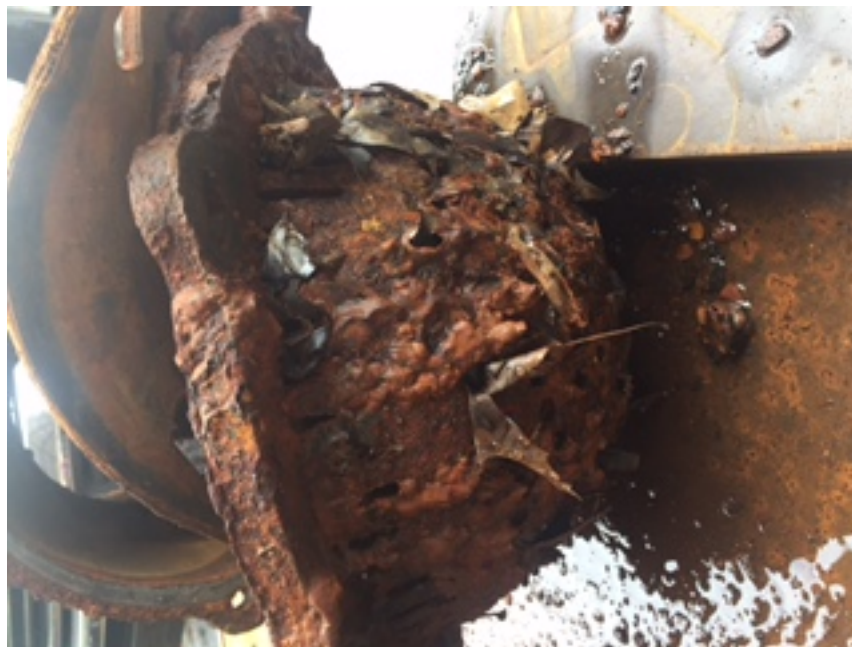
During the testing, it was discovered that there was an issue with two of the four pumps that supply water to the model. Once the sump was dewatered to look at the pump intakes, it was found that the foot valves (check valves) on two of the pumps were corroded to the point that little water could flow way into the pumps (see picture below).

ERDC has agreed to refurbish these foot valves, and have them working for the Agency trip in September. Because of the corroded foot valves, the maximum flowrate that was observed the week of July 17th was 335 kcfs, which was performed on Wednesday the 19th.

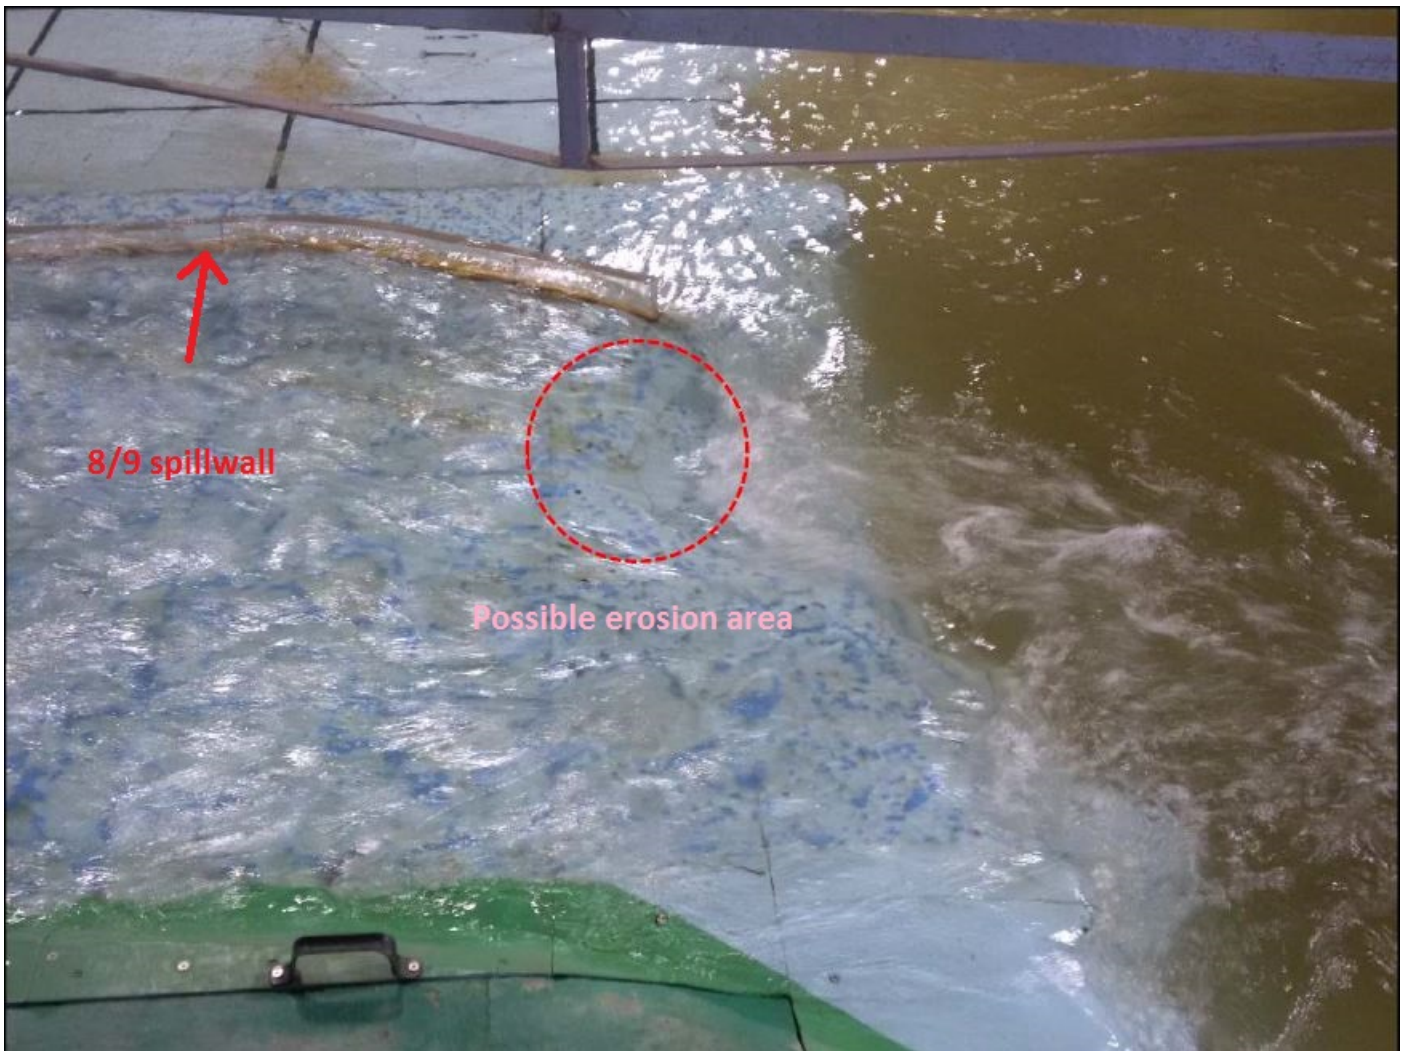
No obvious egress issues were apparent throughout the testing performed on the week of the 17th. The main issue observed was the creation of a large turbulent backroller at the edge of the tailrace shelf, towards the 8/9 spillwall during flow conditions of high spill and low tailwater (see pictures in the section below). Besides the potential issue of entraining juvenile fish in the roller and delaying downstream passage, it appeared to be more of a possible erosion issue at that point. Recommend analyzing future tailwater survey data to see if erosion in

that area is progressing up towards the dam. With the 8/9 spillwall helping to redirect the spill flow into the thalweg powerhouse flow, no unexpected egress issues, or adult upstream passage issues, were observed with the tested operations and flowrates on the week of July 17th.

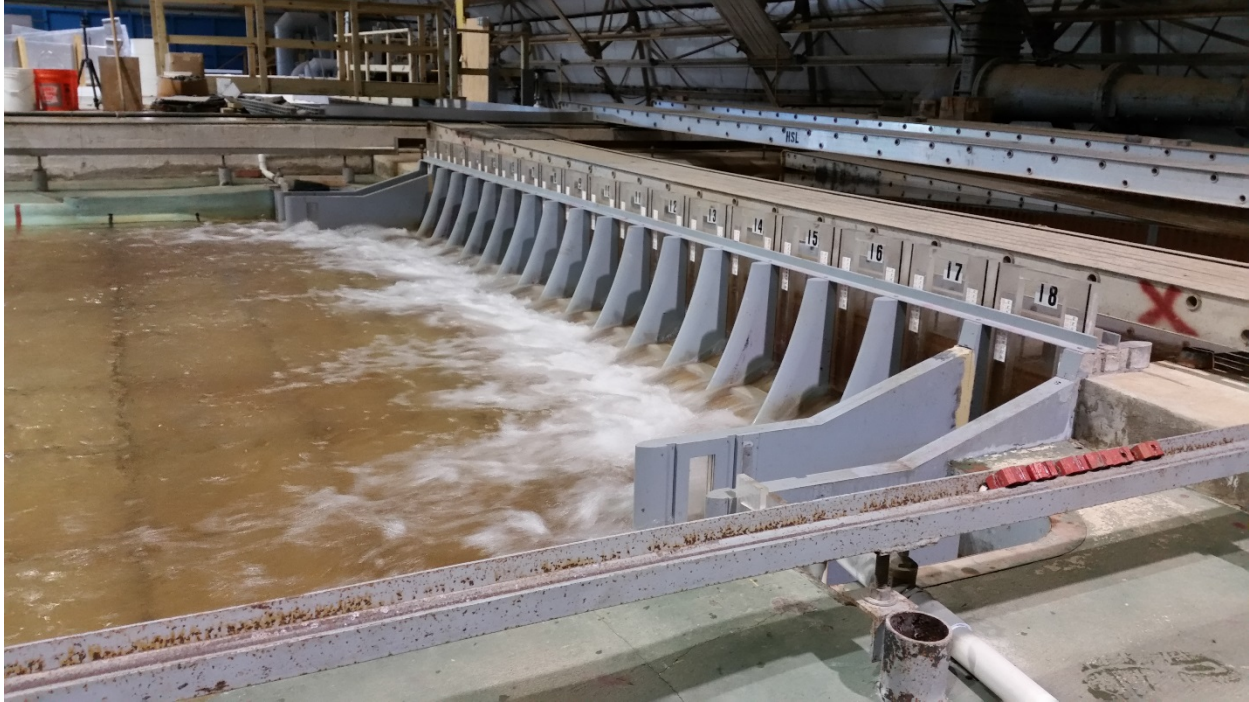
Photo 2 Bonneville Spillway 1:55 Model

TEST: Spillway egress conditions using dye. Velocity also measured for each condition. Want ERDC to retake velocities measurements prior to the September Agency Trip.

Conditions tested are below – test results are shown in Table 4. Green was considered good egress, yellow was okay, mauve questionable and red – dye never got downstream. Times are recorded in Table 4.

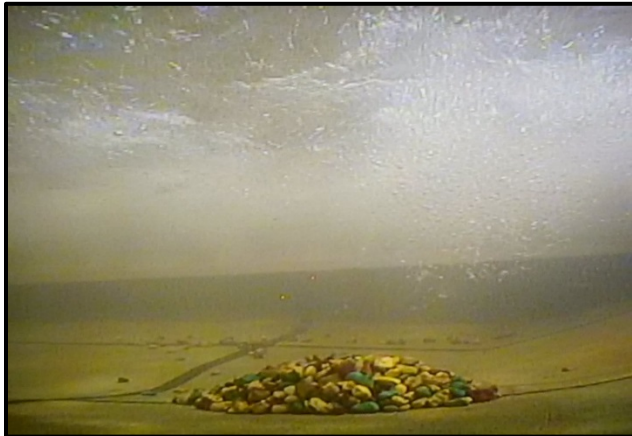
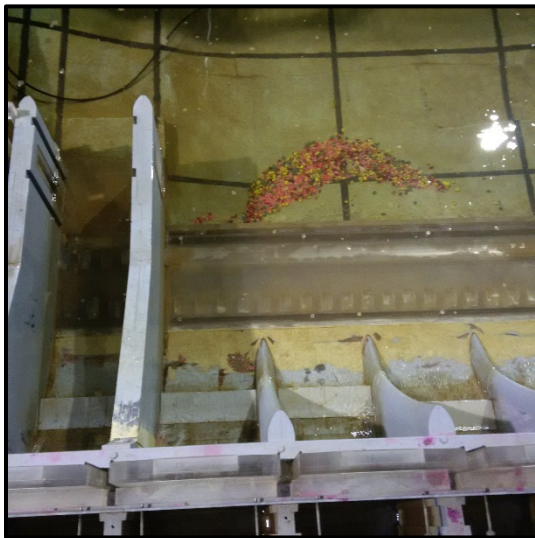
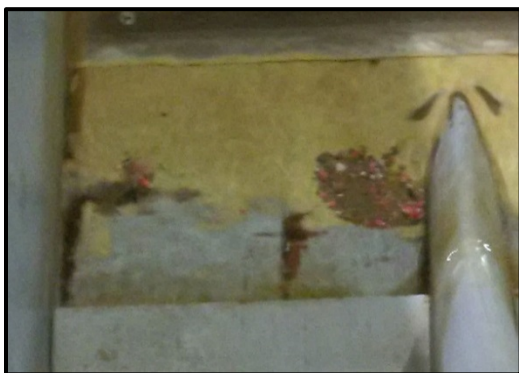
Photos 3-5. TEST: Rock Movement Bonneville Spillway 1:55 model

A pile of rock was placed at the 300 foot mark downstream of the 15/16 pier. If they moved at a specific tailwater more rocks were added. Test were short enough to verify rocks would move onto the ramp. Longer test were done later to figure out final resting place.

An underwater camera was set about 400 to 450 feet downstream of the rocks and rock movement is monitored.
