Separator Monitoring at Bonneville Dam

2020 Annual Report February 2021

Bonneville Juvenile Separator Monitoring 2020 Annual Report

Project Number 1987-127-00
Task Order #W912N-14-P-0042

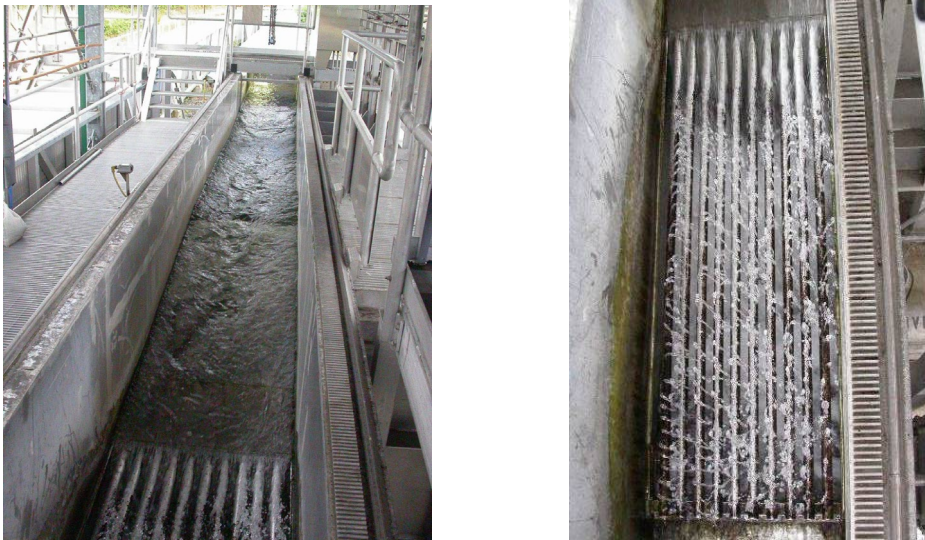
Figure 1. Primary Dewatering Structure (PDS) and the separator bars at the Juvenile Monitoring Facility.

In sample mode, the fish pass over the Primary Dewatering Structure (PDS) where most (29 of 30 cfs) of the water is removed (Figure 1). The remaining water and fish flow onto the large fish and debris

separator (FDS), which is a series of parallel aluminum bars with a 1.25” gap. Juveniles pass through while most of the adults and debris slide off the end and return to the river (Figure 1). Under the separator bars is a collection area known as the “hopper”. A sloped floor directs the juveniles into the distribution flume leading to the facility subsample gate and PIT tag diversion systems. If not diverted by the subsample or research gate, fish return to the river.

Monitoring the PDS and FDS is accomplished via a combination of on-structure and video monitoring from the facility office or laboratory. Staff spent as much time as possible monitoring the separator bars so response time to stranded fish and debris removal could be minimized. Debris removal and screen cleaning at the PDS were accomplished manually. Debris levels at the PDS are recorded on a data sheet and assigned a rating of 1 through 5 (Table 1).

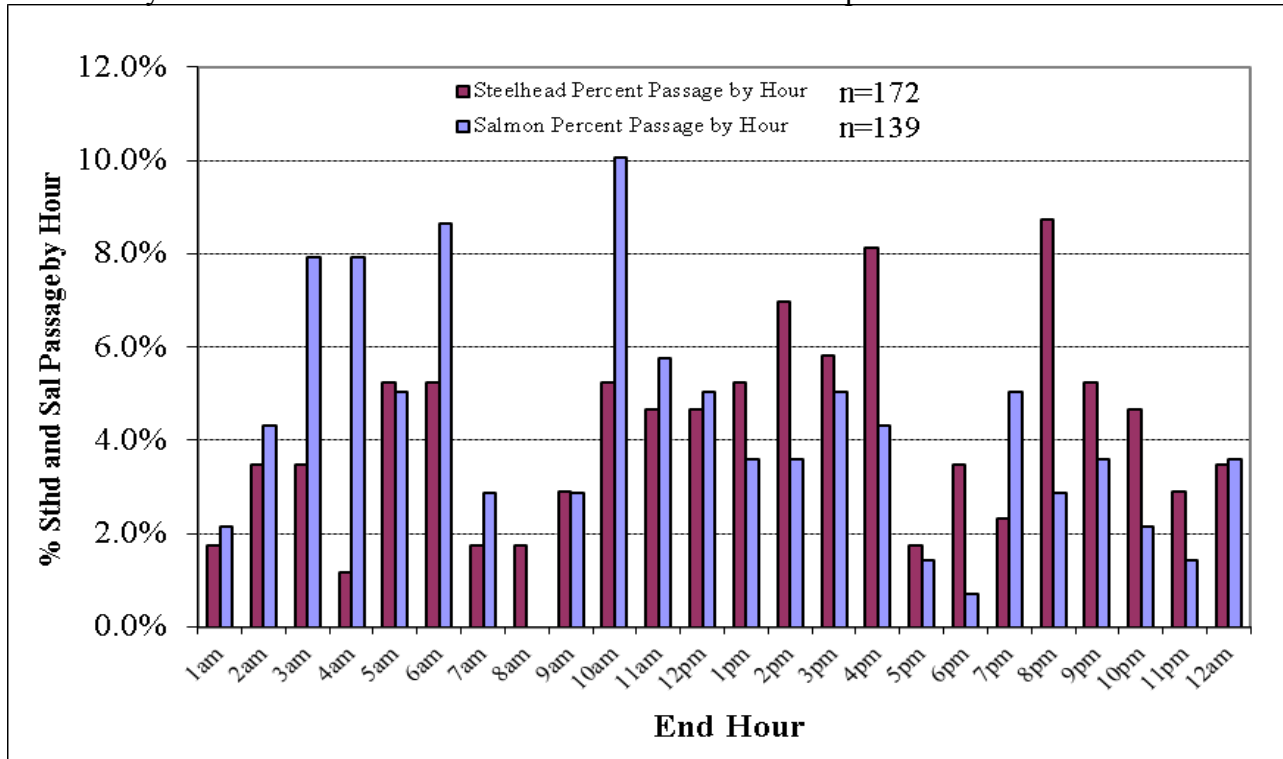
Figure 8. Diel passage of fallbacks, Bonneville JMF in 2020.

Diel passage of steelhead and salmon fallbacks was recorded at the JMF throughout the season. A total of 172 adult steelhead and 139 adult salmon were observed in 2020. Percentage of total fallback passage by hour is presented in Figure 8. Day shift recorded the highest percentage of the total fallbacks observed throughout the season at 42%, while grave and swing shifts noted 31% and 27%, respectively (Figure 9). Approximately 71% of grave shift's steelhead and salmon fallbacks were observed between the hours of 3am and 6am while 65% of swing shift's totals were recorded between 7 and 10pm. Almost 52% of day shift's total fallbacks were recorded between 1 and 4pm.
