The Dalles Fish Water Units 1 & 2

The Dalles Fish Water Turbines Phase 1A Report

Draft Final Report

May 2018

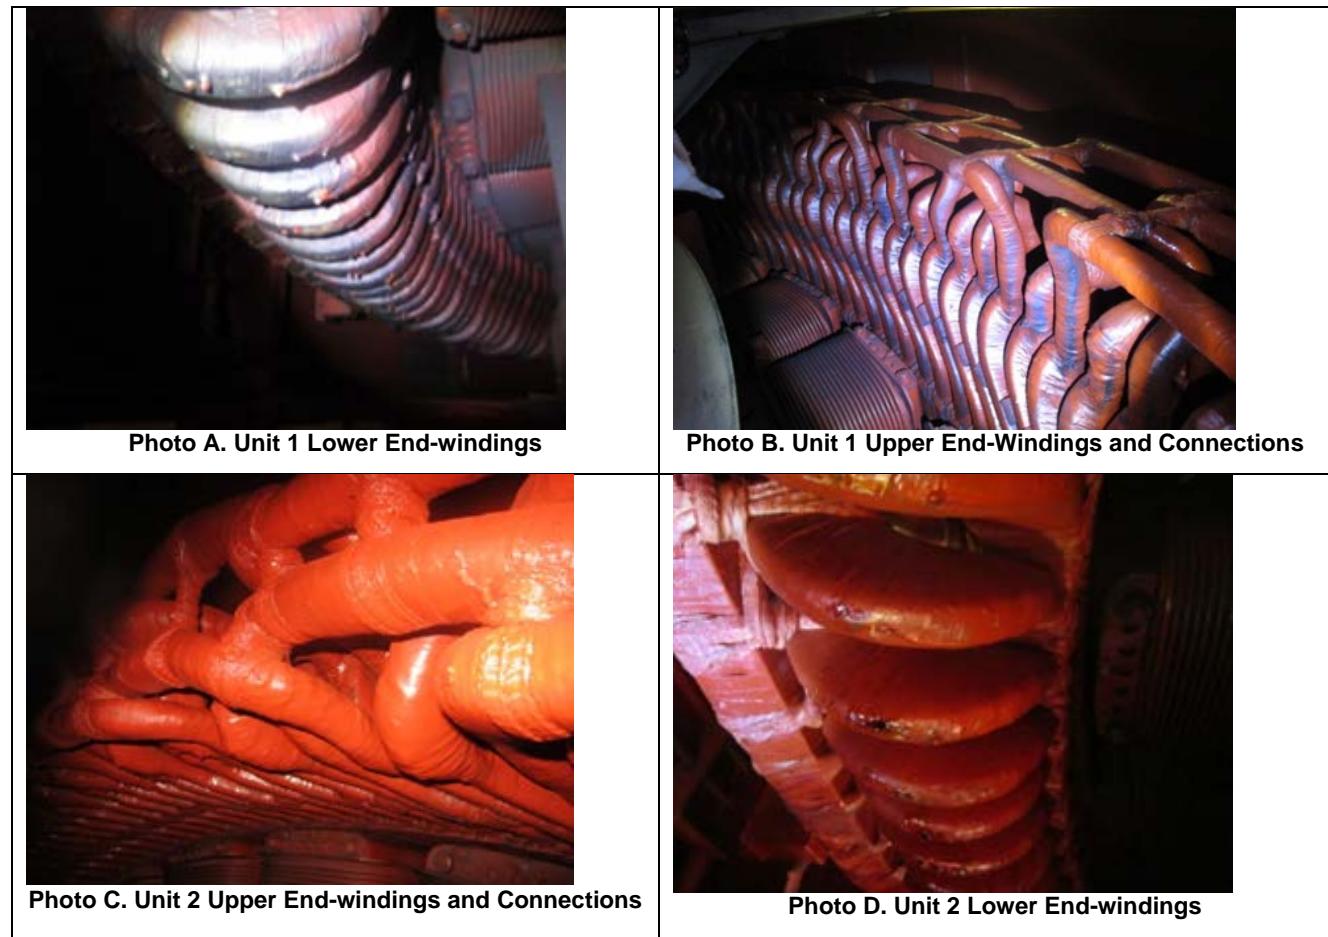
The rotors of both units were still in place. Visual inspections of the stator end-windings were therefore limited. According to the Project, the windings have never been inspected or cleaned since they were rewound in 1997. Findings apply only to the areas visibly observed during the rotor-in inspection. Unit 1 end-windings have oil deposit and covered with brake dust. Unit 2 end-windings were clean and dry. No signs of partial discharge activity or discoloration were evidence on both units. No cracking and bulging of the insulation was found. The blocking, lashing and ties appeared to be tight with no signs of movement. Wedges also appeared tight and there were no signs of migration. Overall the windings in both units appear in fair condition for their age. The rotor poles were inspected from above. There were no signs of movement. Inter-pole connections were examined. They appeared to be in good condition. The main and neutral leads were also inspected. No signs of insulation deterioration were observed.

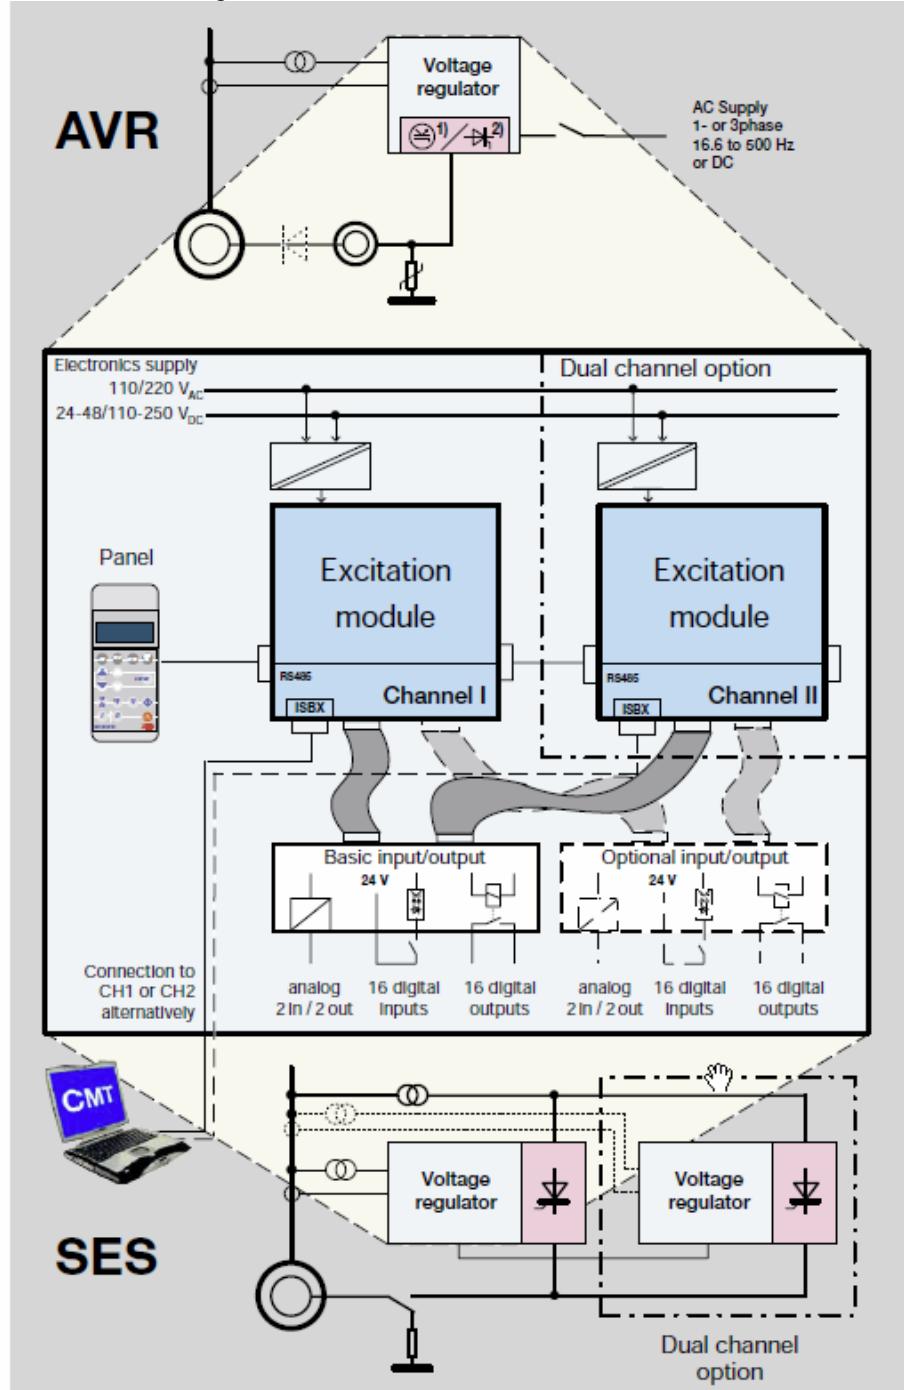
Figure 6. Unitrol F System Configuration

The original rotating excitation systems was replaced with the UNITROL F Series solid state excitation systems by ABB in 2000. While the excitation systems are in satisfactory condition, replacement parts are difficult to locate or are no longer available.

No failures occurred on the excitation system. However, there was a failure on the main Unit 13, which also has UNITROL F model.

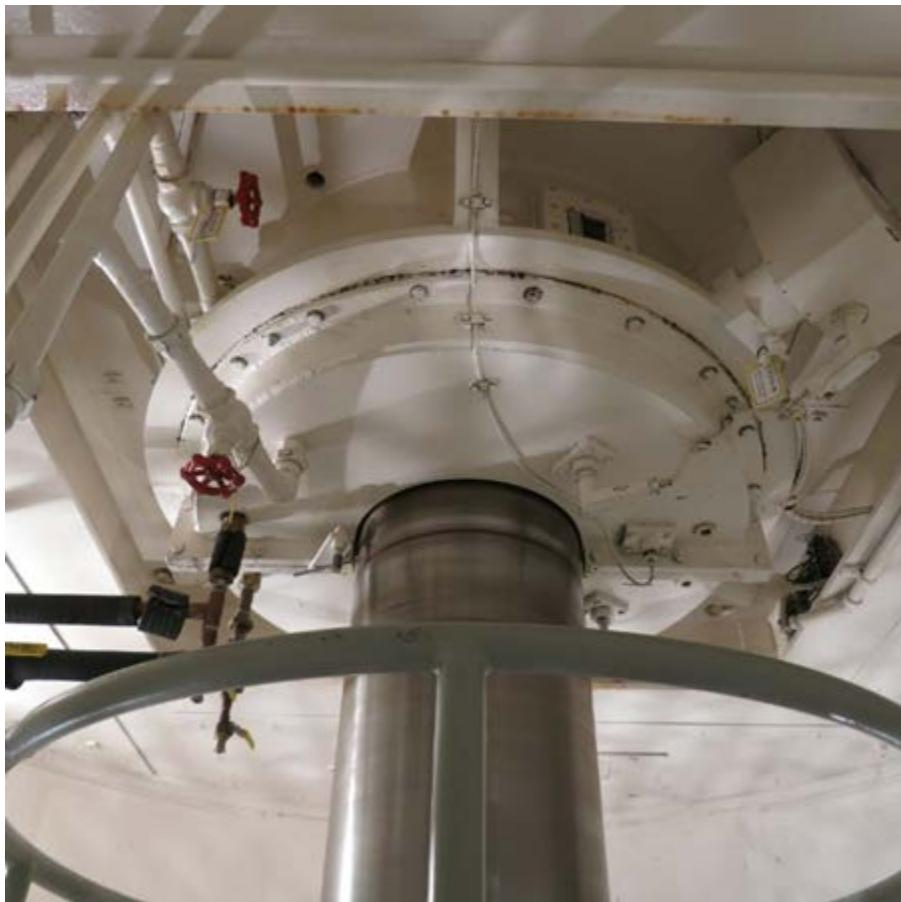
Figure 14. Lower Generator Guide Bearing

There are two generator guide bearings. The upper generator guide bearing uses the OD of the thrust collar as the journal. There are fourteen guide shoes for this bearing with the journal OD being 52-3/8 inches. The lower generator guide bearing is mounted around the journal on the generator shaft. There are eight guide shoes for this bearing with the journal OD being 28-1/2 inches. Neither of these bearings are accessible for easy inspection, however it is rare that generator guide shoes would fail in operation. During a rehabilitation these bearing shoes will be inspected and most likely it will be an opportunity to rebabbitt them. The Dalles project has a spare set for both of these bearings.

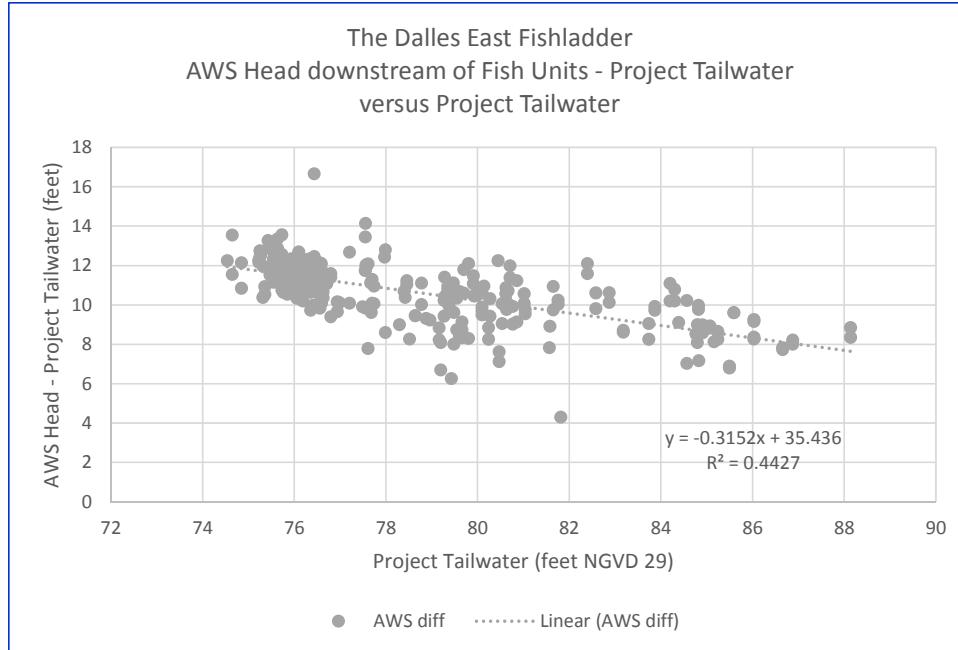
Figure 4 – Comparison of Estimated and Recorded Differences between AWS Head and Project Tailwater

As the tailwater becomes higher, the overall hydraulic efficiency of the AWS system becomes higher as additional lower ladder diffusers come on line. The trend showing the decreased headloss as a function of higher tailwater is shown in the figure below. Attempts to improve the relationship using multivariate regression did not lead to a significant improvement in the correlation.

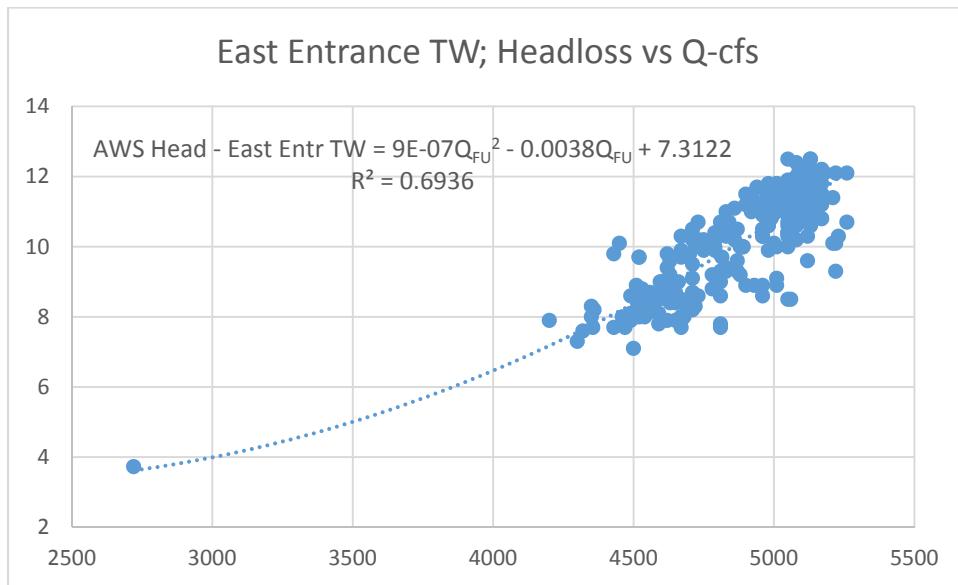
Figure 5 – Comparison of Estimated and Recorded Differences between AWS Head and East Entrance Tailwater

Additional correlations were made with recorded data from the East, West and South entrance tailwater elevations. The best correlation was with the East entrance tailwater elevation.

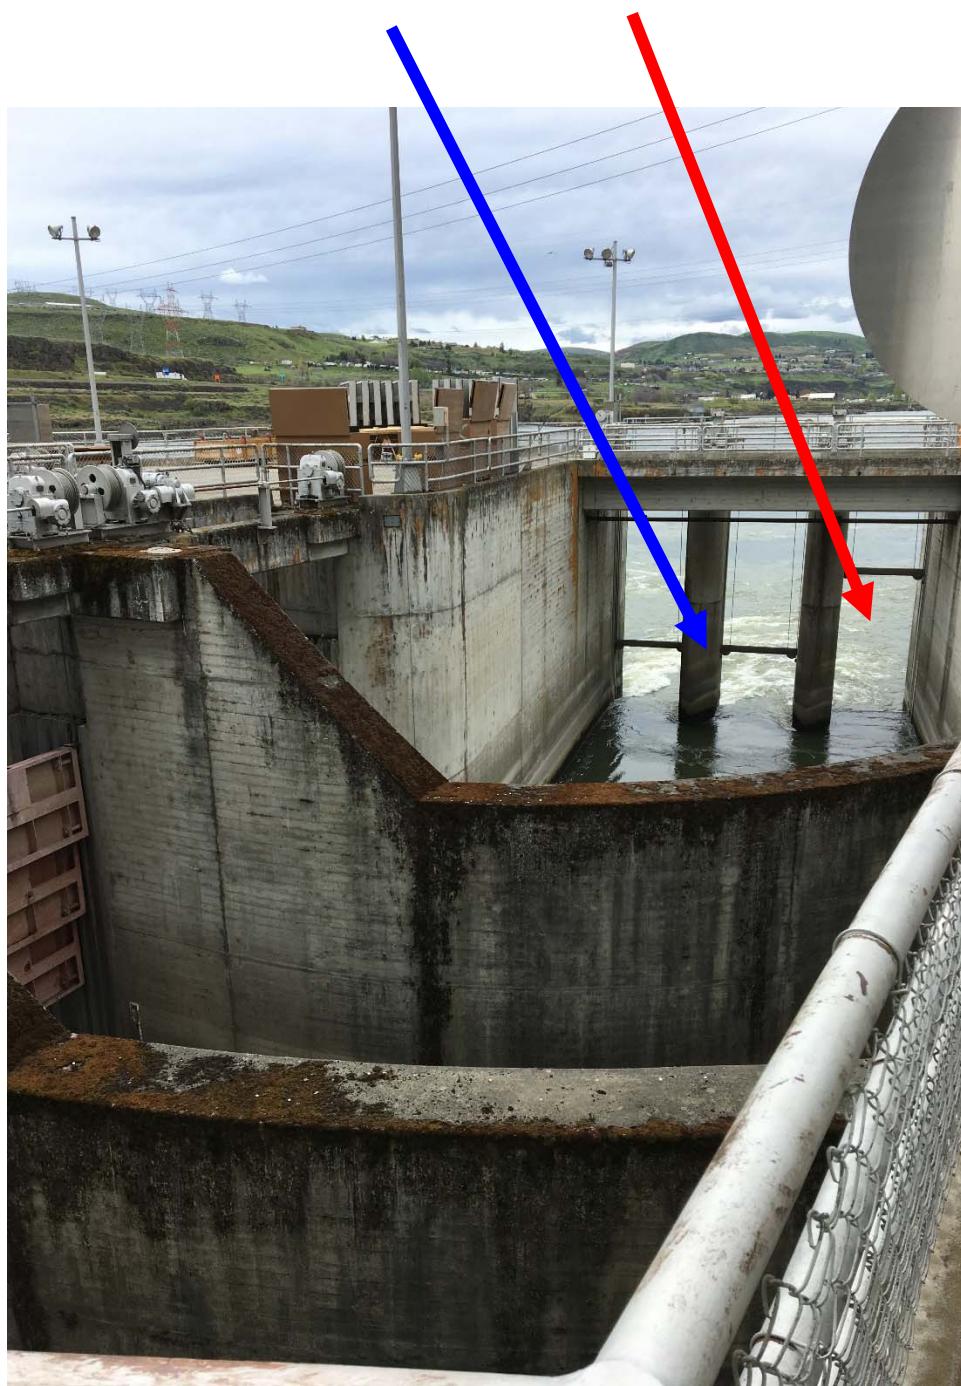
Location on 111.5 ft. deck of TW reading for E. Entrance.

Note two weirs are discharging, E3, E2 (E1 on the right nearest to the Powerhouse is closed).

Photo 1: East EFL Entrance – looking D/S w/ The Dalles, OR in the distant background.

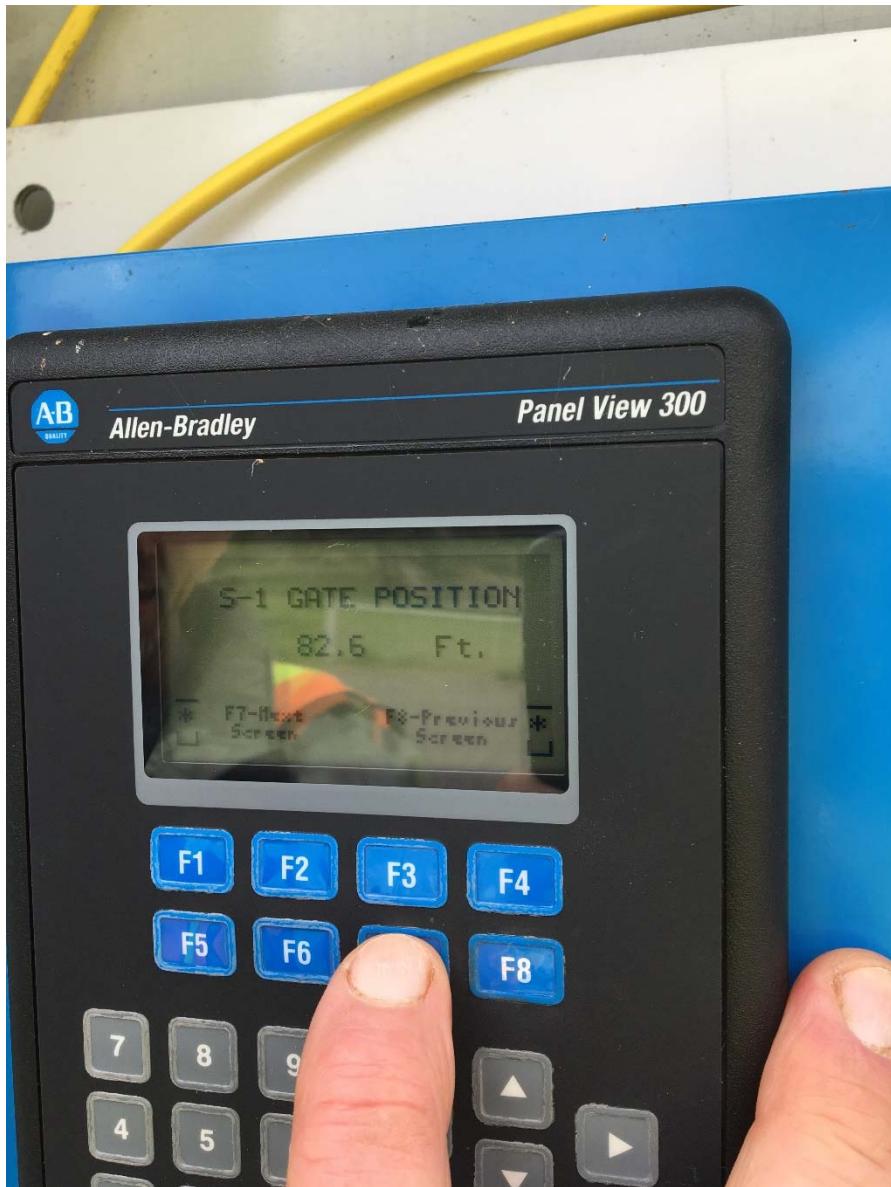
Photo 4: Panel outside of PH showing gate position in EFL entrances, typ.
