SECTION 17 F, DOWNSTREAM FROM AXIS OF DAM

| EONNEVILLE PROJECT | | CONTRACT NO. 100-100 | |
| SECTION 17 F, DOWNSTREAM FROM AXIS OF DAM - SOUTH LIMIT SP. 4.5. | | R.Y. R/W LINE TO PIER W-4 | |

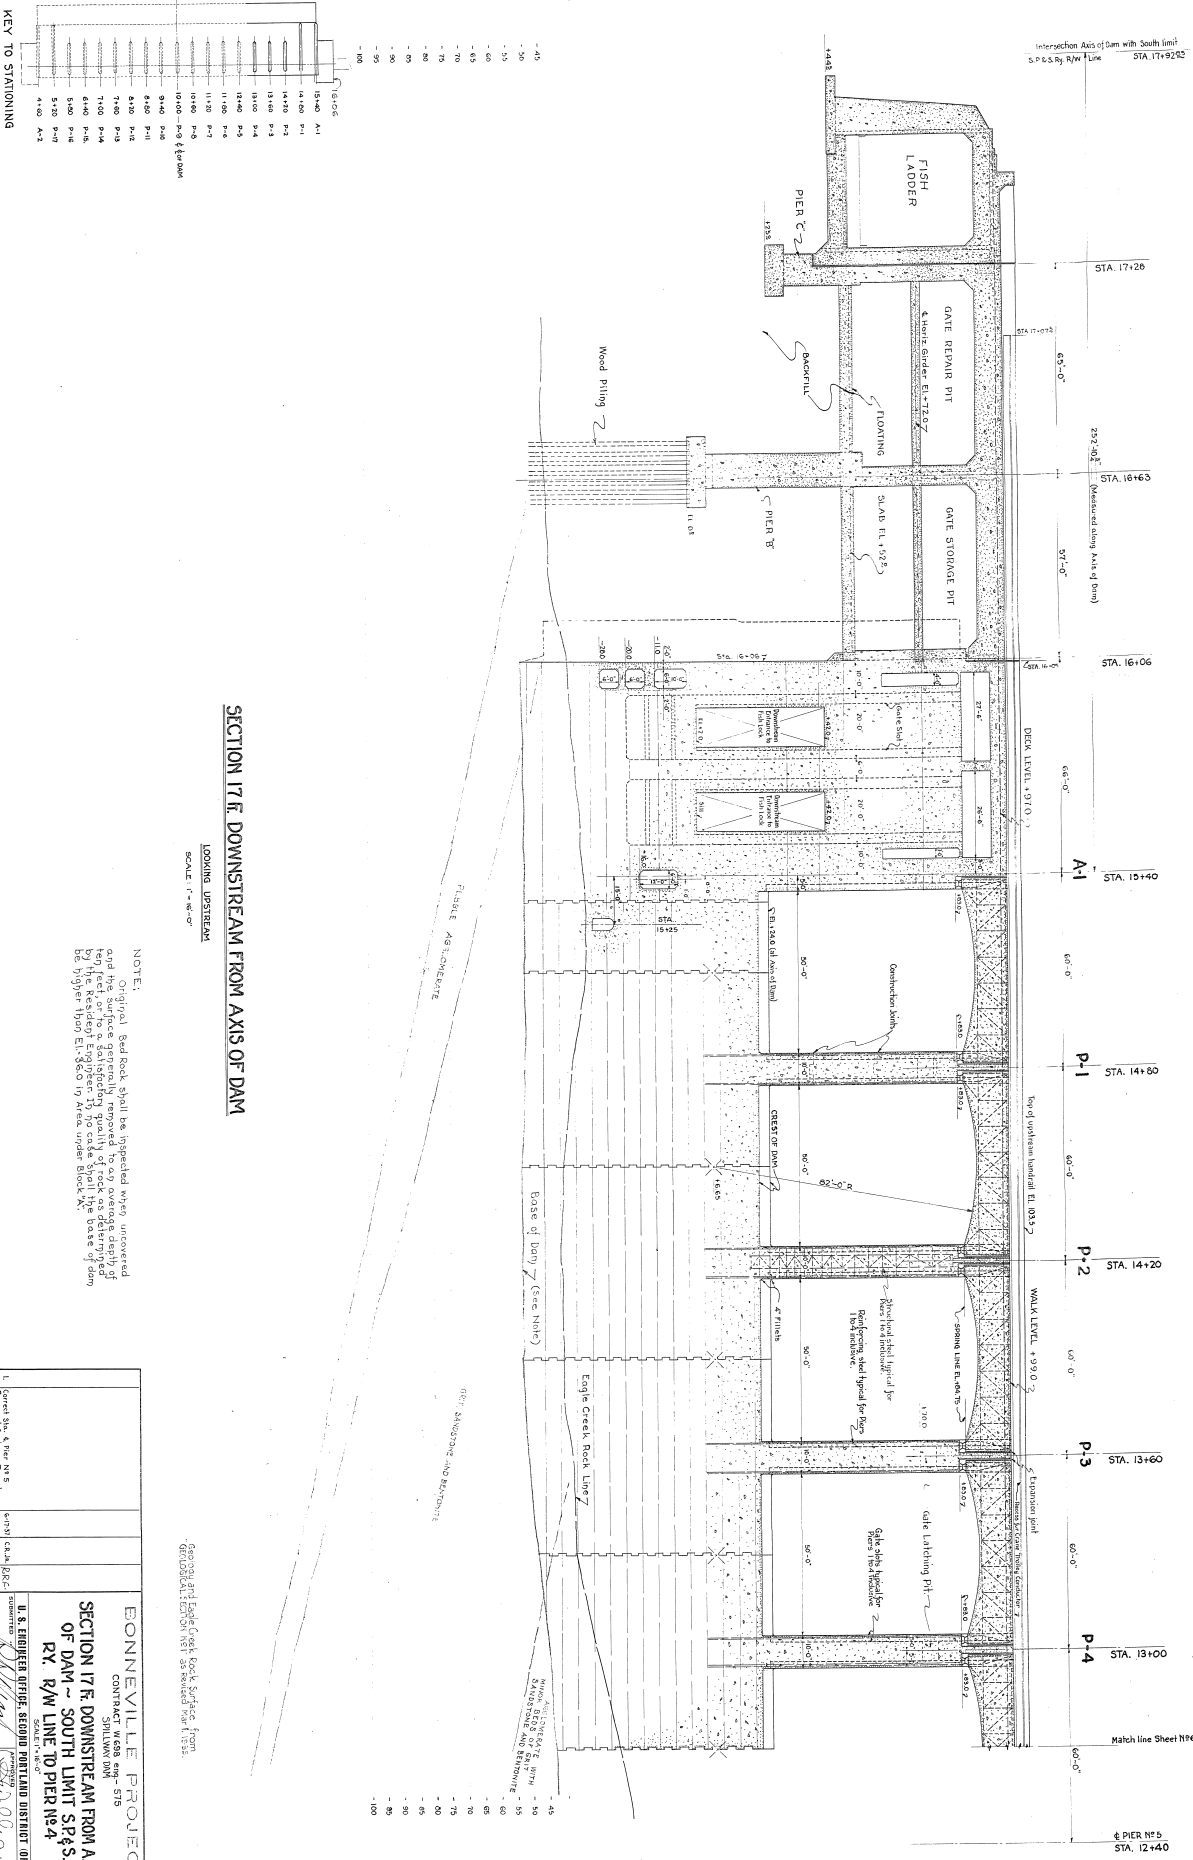
NOTE:  
Original Bad Rock should be inspected when uncovered and the surface generally removed to an average depth of 12 inches. If the rock is found to be of good quality, it may be left in place. If the rock is found to be of poor quality, it should be removed. The base of the dam should be higher than EL. 36.0 in Area under Block V.

LOOKING UPSTREAM  
SCALE 1" = 40'-0"
