OBJECTIVES: A multipurpose agency trip was conducted at Engineering Research Design Center (ERDC) during the week of September 17-22 to observe spill patterns in models representing Bonneville, The Dalles and Lower Monumental dams. This report pertains to the modeling conducted at The Dalles 1:80 general model. The objective of this trip was to review comparative spill patterns between the current Fish Passage Plan at 40% spill and raised spill rates up to the “gas cap” as directed by a recent Court Order. The intent of the increased spill is to maximize juvenile fish passage through the spillway without harming egress. Other possible concerns included potential impacts on navigation, adult passage or the structural integrity of the spillwall and other dam features due to erosion. The raised spill patterns represent higher percentages of spill up to the “gas cap” that have been estimated by SYSTDG modeling conducted by USACE Northwestern Division (NWD).

Fish Passage Concerns/Issues

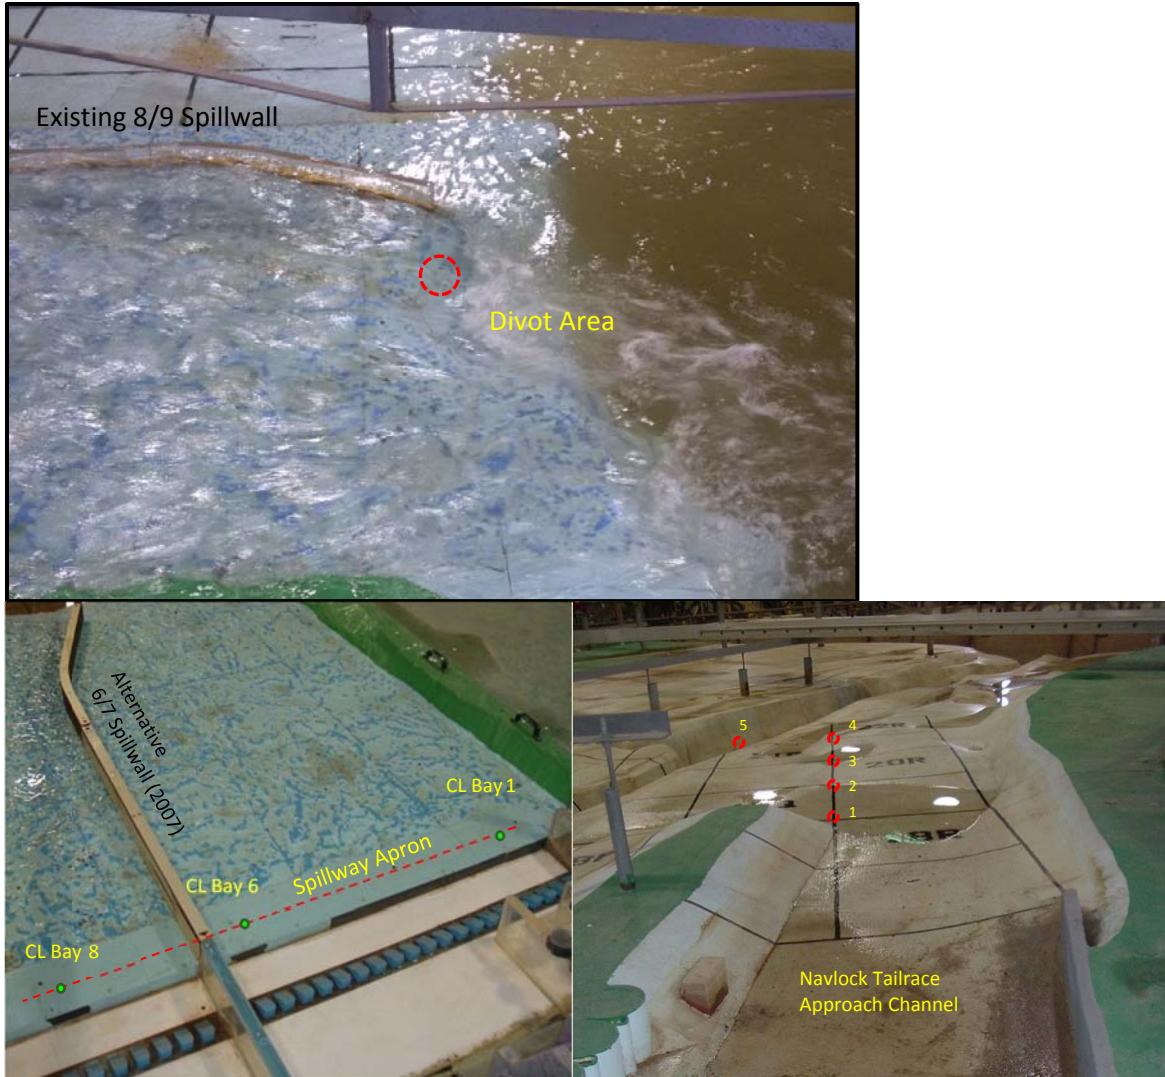
Figure 1 - Velocity Data Measurement Locations

The locations of the velocity tests are shown in the photos provided in Figure 1. The picture on the lower left has the apron locations; the picture on top shows the measurement location for velocity on the slope approaching the divot; the picture on the lower right shows the point locations for the Navlock tailwater approach channel.

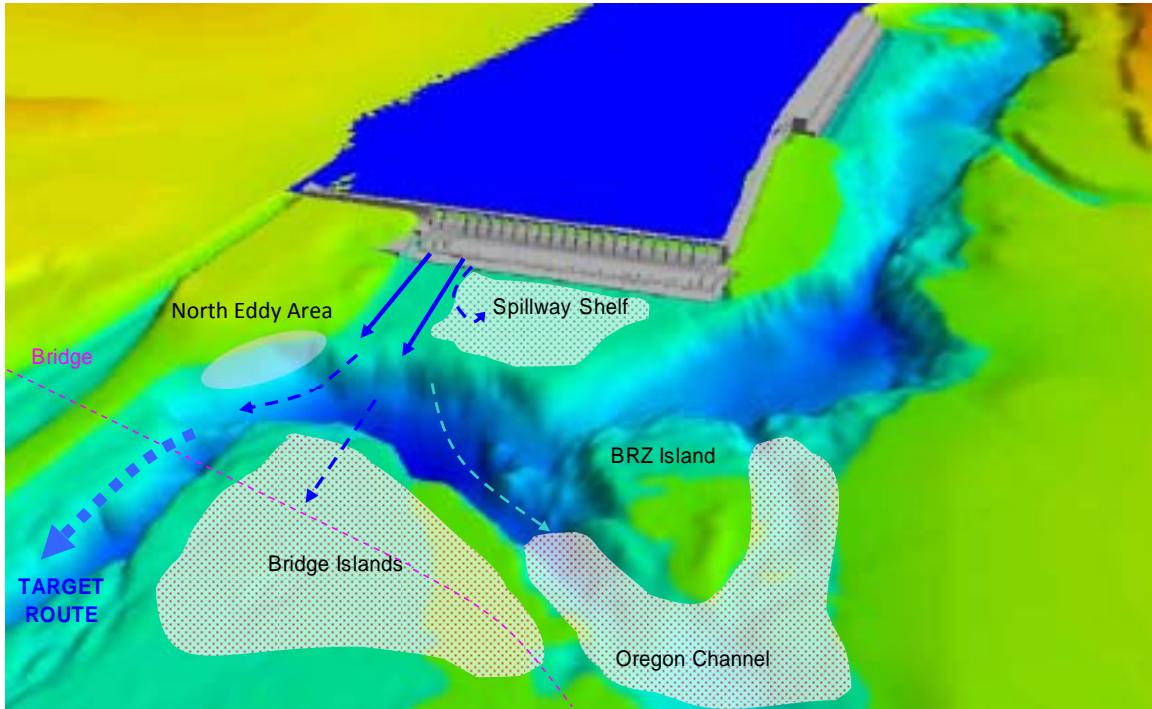
Figure 2 - Egress Destination Zones of High Predator Risk for Juvenile Fish Discharged Through Spillway

Areas of egress hazard were shown to the visitors and are highlighted in Figure 2. It has been a general consensus that any spill within the spillwall does not send dye into these egress hazard areas. Laurie described the problem with spillway gates 9 (trunnion pin), 10 and 11 (wire ropes).

Excellent: No dye enters the primary hazard zones (See Figure 2: Bridge Islands, Spillway Shelf or Oregon Channel) and moves directly down the westward channel downstream of spillway.

Test 1 was at 120 kcfs river flow at The Dalles and 40% spill. The spillway flow was 48 kcfs at 4 feet gate openings within bays 1-8. The 4-feet gate opening represents the minimum allowable gate opening for juvenile spill, below which fish are retained too long in the stilling basin and direct mortality goes up. The Test 1 tailwater represented a median tailwater for river flow 120 kcfs (BFB = 74.6 feet). Egress through bays 8, 6, 4, and 1 was excellent (By ‘excellent’: meaning no dye entered the primary hazard zones (Bridge Islands, Spillway shelf, or Oregon Channel showed on Figure 2) and all dye moved down the westward channel).
