BONNEVILLE DAM
COLUMBIA RIVER BASIN
CASCADE LOCKS, OREGON

BON Spillway Rock Mitigation

Phase 1A Report – Final

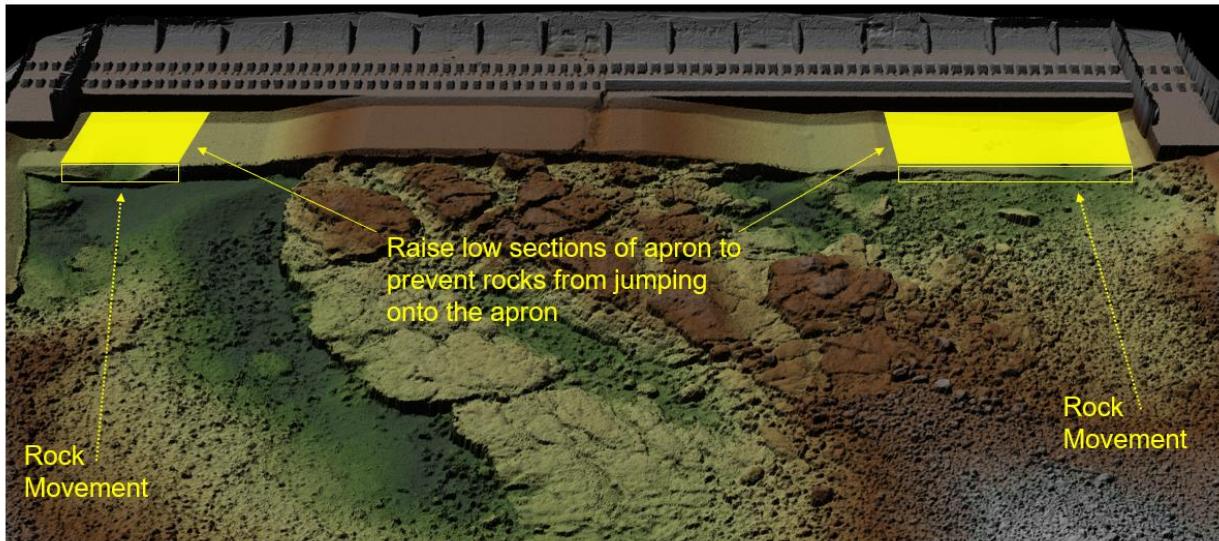
Figure 2-3. Conceptual “Raise” Alternative.

This alternative (also referred to as “Raise”) consists of raising the low spots on the north and south ends of the apron sufficiently high so that rocks are unable to neither move onto nor make their way up the apron (Figure 2-3). This alternative would require a large quantity of concrete to be placed underwater. Total quantity of concrete is expected to greater than the barrier alternative. Underwater form work will be required in water depths up to 60 to 70 feet. Divers may be required to anchor the forms to the concrete apron. The south side of the apron has a wider low spot which will require more concrete to raise than the north side. How high to raise the apron and hence the number of lifts, will have to be determined. It should be raised enough that if rocks accumulate downstream of the raised spots, they are not able to pile up and maneuver onto the apron.
