## Bonneville Spillway – High Flows and Tailwater Impacts

Laurie Ebner

July 2024

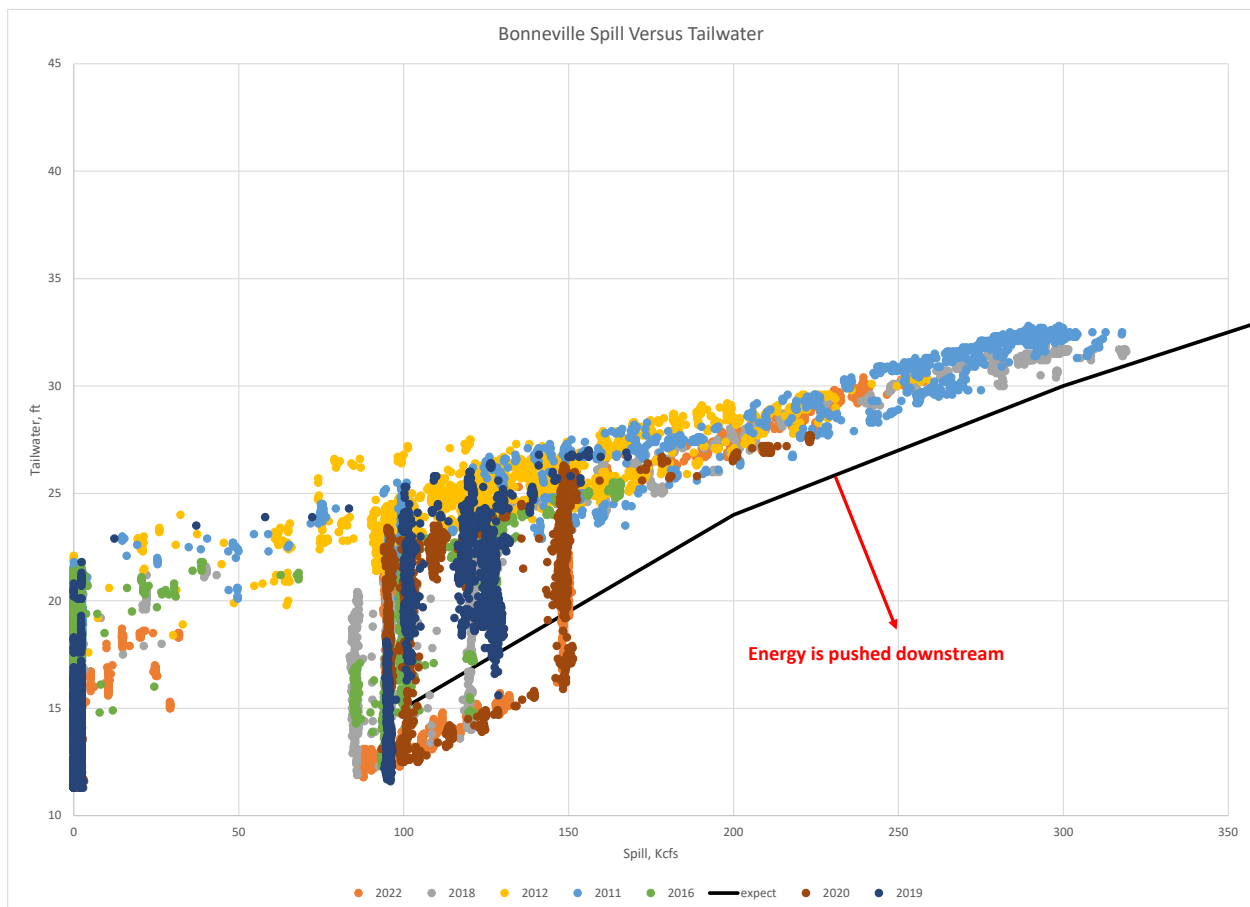
The spill at Bonneville has changed over time – Figure 4 shows spill volume versus tailwater. The solid line is the minimum design tailwater that should exist for that particular spill volume. In recent years, Bonneville has adopted the practice of high spill volumes and low tailwater. Table 1 provides insight on how often the tailwater was too low for the spill volume.

*Figure 4 – Bonneville Spill Volume Versus Tailwater*

When data is to the left of the solid line shown in Figure 4, the design energy dissipation is occurring in the stilling basin. When data is to the right of the line, the stilling basin is not dissipating sufficient energy and energy is pushed downstream.

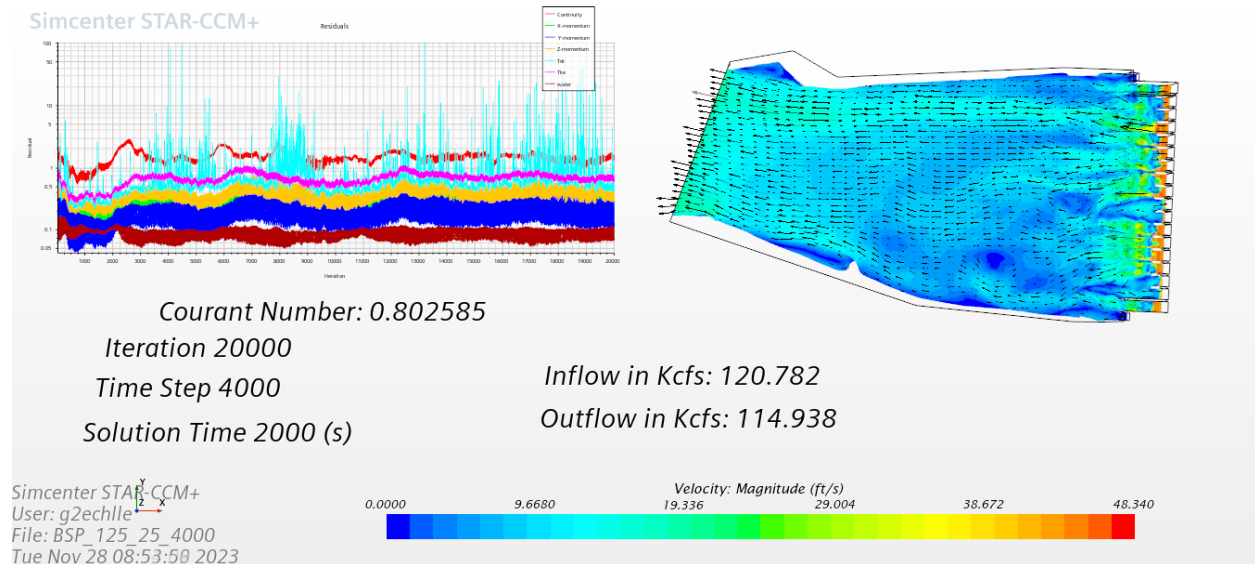
An example output is shown in Figure 5. The figure shows a standard output file with the inflow, outflow, residual, Courant Number. The image of the spillway shows the surface velocity.

Figure 5 - CFD Model Output – 125 Kcfs Spill and 25 foot tailwater

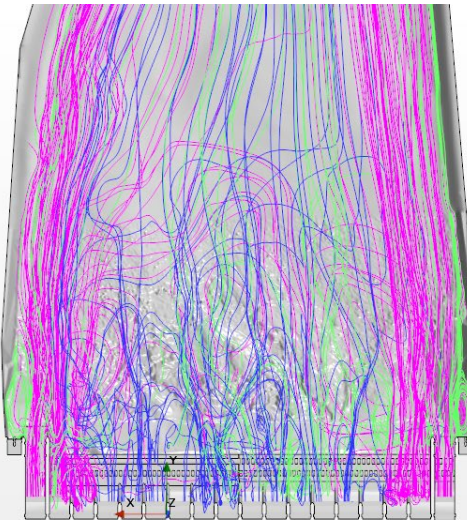
*Figure 24 – Streamlines for 125 Kcfs Spill and 25 foot Tailwater*

Images for all of the CFD model runs are in the attached PowerPoint file. Figure 23 through Figure 26 show conditions where the general movement of the streamlines was downstream.
