MEMORANDUM FOR THE RECORD 19 LGS 01 Auxiliary Water Supply (AWS) Pumps**SUBJECT: Little Goose Auxiliary Water Supply Pumps Intermittently Out of Service****Updated After Action: March 27, 2019****Background**

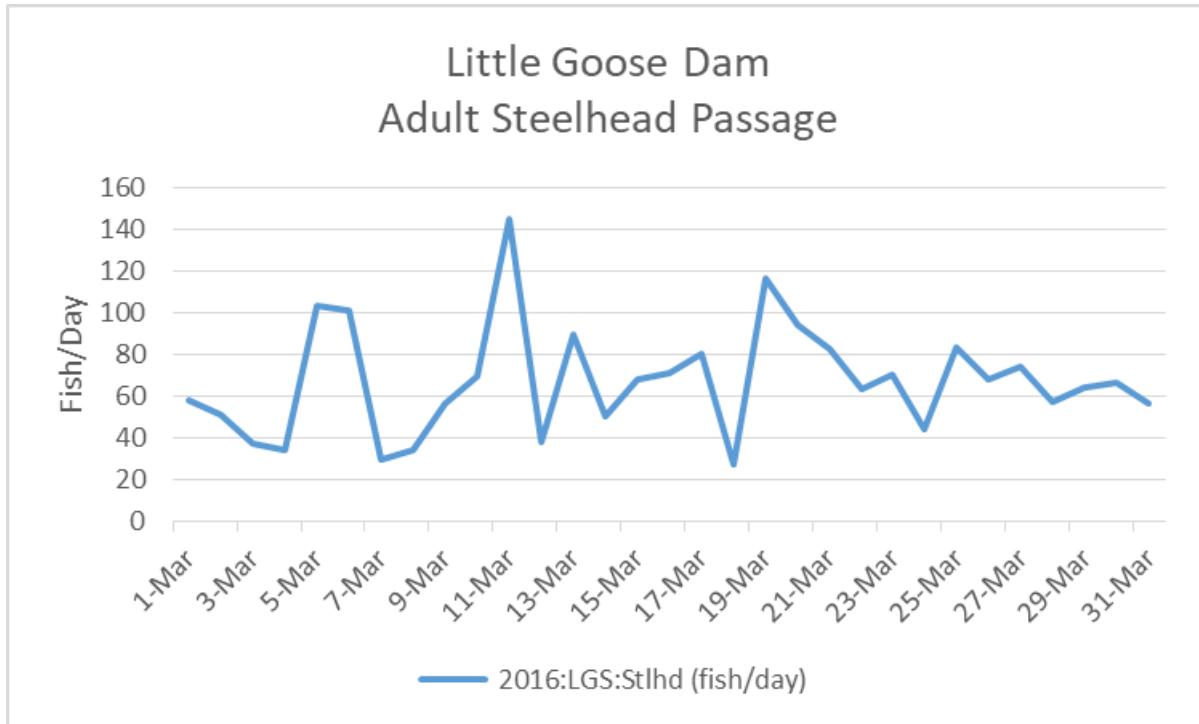
Figure 1: Adult steelhead counts at Little Goose Dam, March 2016.

Adult passage at Little Goose is typically very low during the month of March, predominately made up of adult steelhead. The most recent adult counts occurred in 2016, with the daily average adult count of 67 steelhead per day (Figure 1). Adult fish counts are not currently being conducted at Little Goose and will resume on April 01.
