SUBJECT: Submission of 2019 Adult and Juvenile Fish Facility Monitoring Report, Ice Harbor Dam.

2019 ADULT AND JUVENILE FISH FACILITY MONITORING REPORT
ICE HARBOR DAM

U.S. Army Corps of Engineers

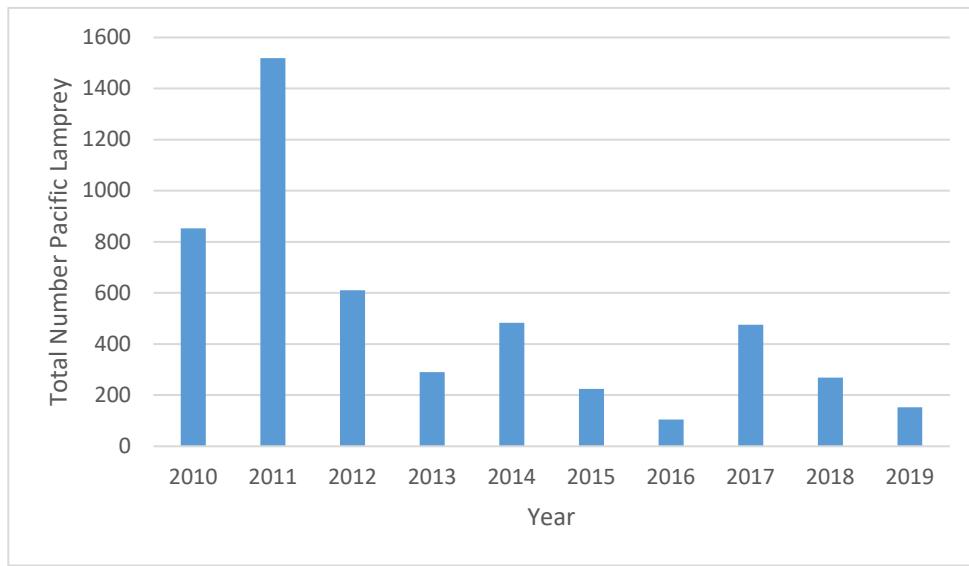
Figure 1. Yearly total number of Pacific Lamprey removed from turbine unit cooling water strainers at Ice Harbor Dam, 2010-2019.

The total number of juvenile Pacific lamprey that were found in the turbine cooling water strainers in each of the last ten years is shown in Figure 1. In general, there has been a trend of decreasing numbers of lamprey found in the strainers since 2010. The reason for this trend is unknown without further investigation of the strainer data, lamprey population trends, and the associated environmental conditions.

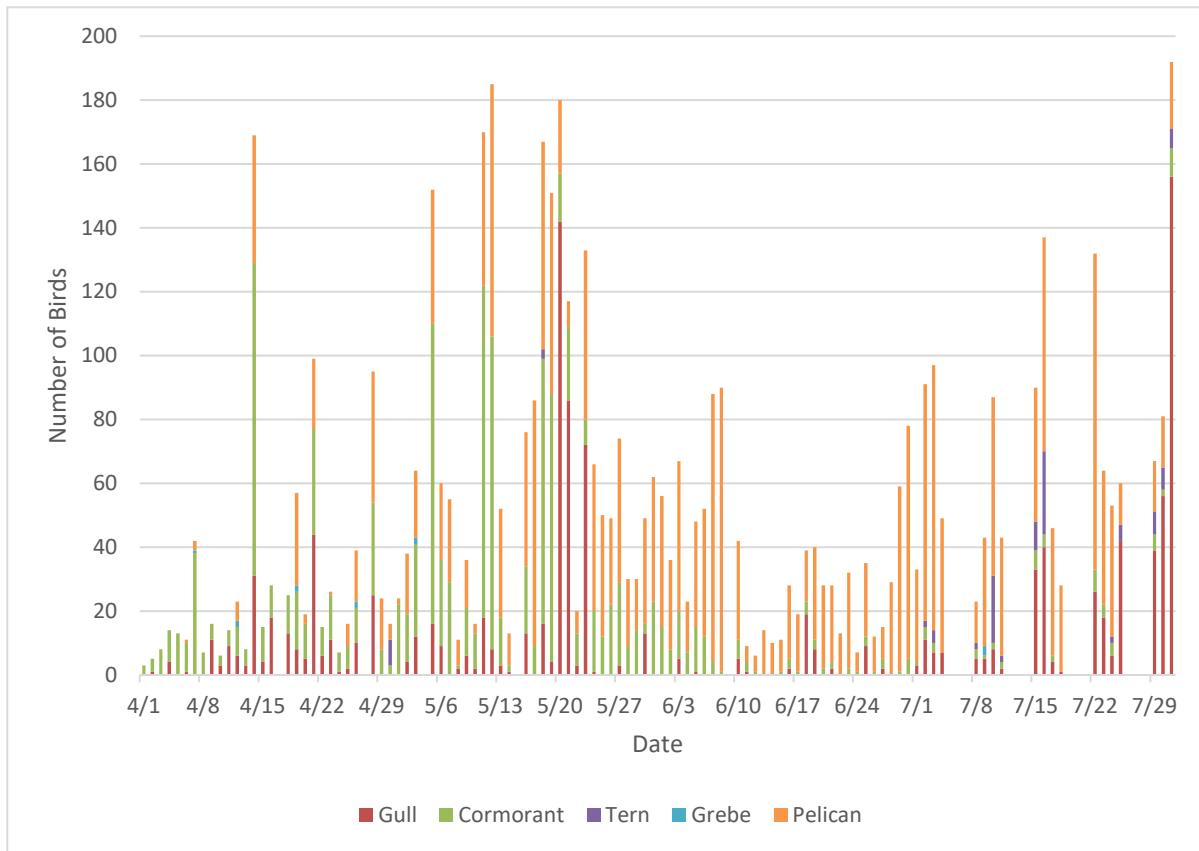
Figure 2. Daily number of piscivorous birds counted at Ice Harbor Dam, 2019.

The U.S. Department of Agriculture (Wildlife Services) utilized pyrotechnics to conduct land-based hazing of piscivorous birds from April 1 to June 30, 2019. In addition, boat-based hazing occurred from April 7 to June 8. Bird deterrent structures at the project include roosting deterrents, a water cannon at the juvenile fish bypass outfall pipe, and a wire array in the tailrace. Propane cannons are available to deploy as additional aids to harass birds in areas where there are continual predation problems. Piscivorous bird counts were conducted daily from April 1 to June 30, and four days per week in July (Figure 2), to track whether the harassment/deterrent program remained effective at reducing bird abundance around the dam. Land-based hazing was effective at pushing birds away from the immediate vicinity of the dam. The boat-based hazing was particularly effective at further removing birds from the downstream spillway and powerhouse tailrace zones. Double-crested cormorants were usually the most abundant piscivorous bird species observed during daily bird counts from April 1 to the middle of May. American white pelicans were then the predominant species for the rest of the bird count season. Total bird numbers decreased in June, then increased again in July. Birds may have keyed in on the juvenile shad run in the late summer through the end of the year.

The average of total daily number of cormorants, gulls, and terns counted per week in 2019 was usually within the range of averages for the same weeks over the previous four years (see Table 10). The avian abundance action trigger for increasing hazing efforts (see the Ice

Harbor section of Appendix L of the Fish Passage Plan) was reached on eight days during the spring. However, the bird counts on some of those days occurred just before hazing began for the day or when boat-based hazing was not actively occurring. The other occurrences where the action trigger was met were generally isolated events and not on continuous days. Gulls and cormorants were spread out in different observation zones during these events and were not targeting a specific fish passage route. The scheduled hazing effort and methods already in use adequately reduced spikes in bird numbers.
