SUBJECT: Submission of 2023 Adult and Juvenile Fish Facility Monitoring Report, Ice Harbor Dam.

2023 ADULT AND JUVENILE FISH FACILITY MONITORING REPORT
ICE HARBOR DAM

U.S. Army Corps of Engineers

December, 2024

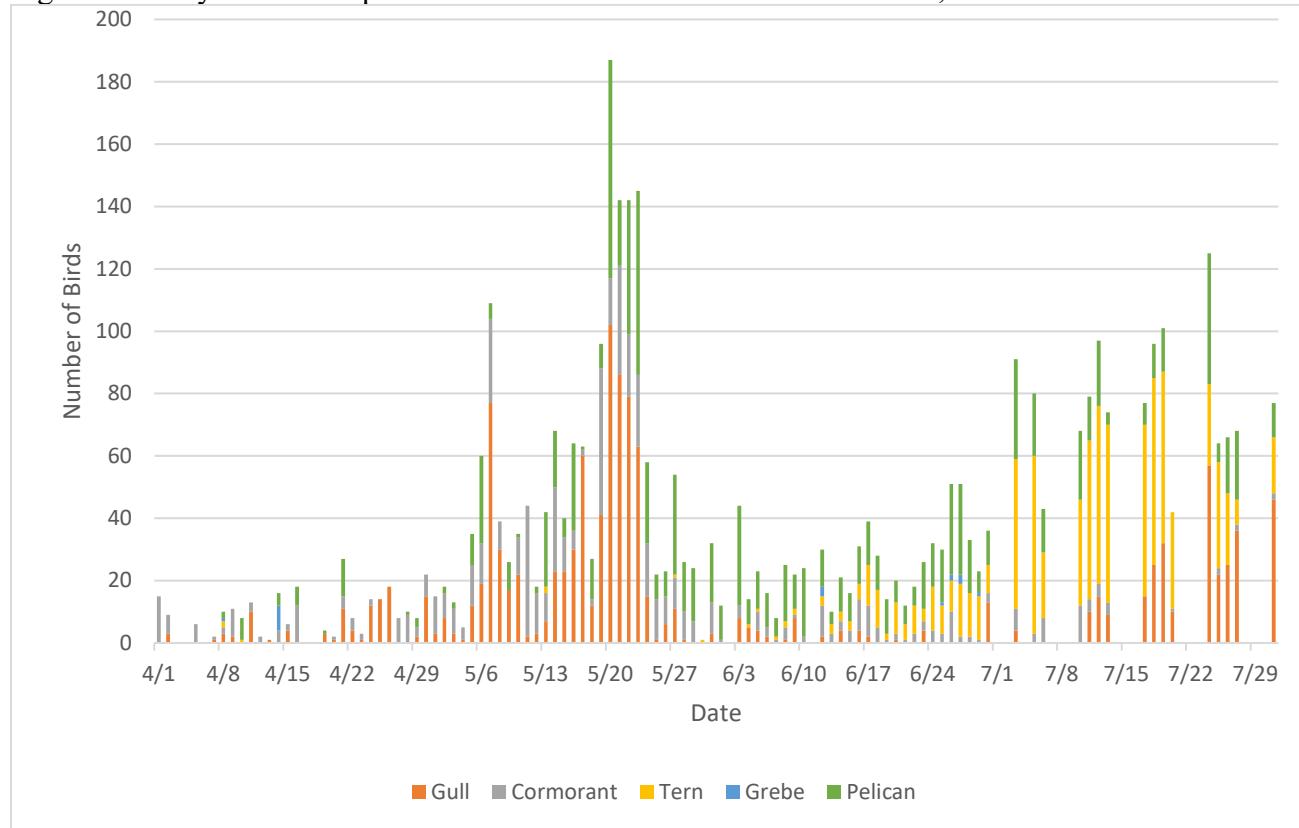
Figure 1. Daily number of piscivorous birds counted at Ice Harbor Dam, 2023.

The U.S. Department of Agriculture, Wildlife Services, utilized pyrotechnics to conduct land-based hazing of piscivorous birds from April 1 to June 30, 2023. In addition, boat-based hazing occurred from April 9 to June 10, and July 17 to July 31. Bird deterrent structures at the project include roosting deterrents, a water cannon at the juvenile fish bypass outfall pipe, and a wire array in the tailrace. Propane cannons are available to deploy as additional aids to harass birds in areas where there are continual predation problems. Piscivorous bird counts were conducted daily from April 1 to June 30, and four days per week in July (Figure 1), to track whether the harassment/deterrent program remained effective at reducing bird abundance around the dam. Land-based hazing was effective at pushing birds away from the immediate vicinity of the dam. The boat-based hazing was particularly effective at further removing birds from the downstream spillway and powerhouse tailrace zones. Double-crested cormorants were usually the most abundant piscivorous bird species observed during daily bird counts in early April, with gulls and American white pelicans becoming the predominant species for the next several months. There were more terns observed than other birds in July. Total bird numbers dipped in June, then increased again in July. Birds may have keyed in on the juvenile shad run in the late summer through the end of the year.

The average daily total number of cormorants, gulls, and terns counted per week in 2023 was usually within the range of the averages for the same weeks over the previous four years, but higher than the averages for the last three weeks in July (see Table 11). Since 2019, there has been a significant bird presence at the project in the month of July, after active bird hazing ended for the season. In 2023, boat-based hazing was requested for the latter half of July to deal with the terns. The avian abundance action trigger for increasing hazing efforts (see the Ice Harbor section of Appendix L of the Fish Passage Plan) was reached on a total of 24 days, eight days
