**2015 ADULT AND JUVENILE FISH FACILITY MONITORING REPORT
ICE HARBOR DAM**

MARCH 2024

Prepared by
Kenneth R. Fone
Ice Harbor Project Fisheries Biologist
U.S. Army Corps of Engineers

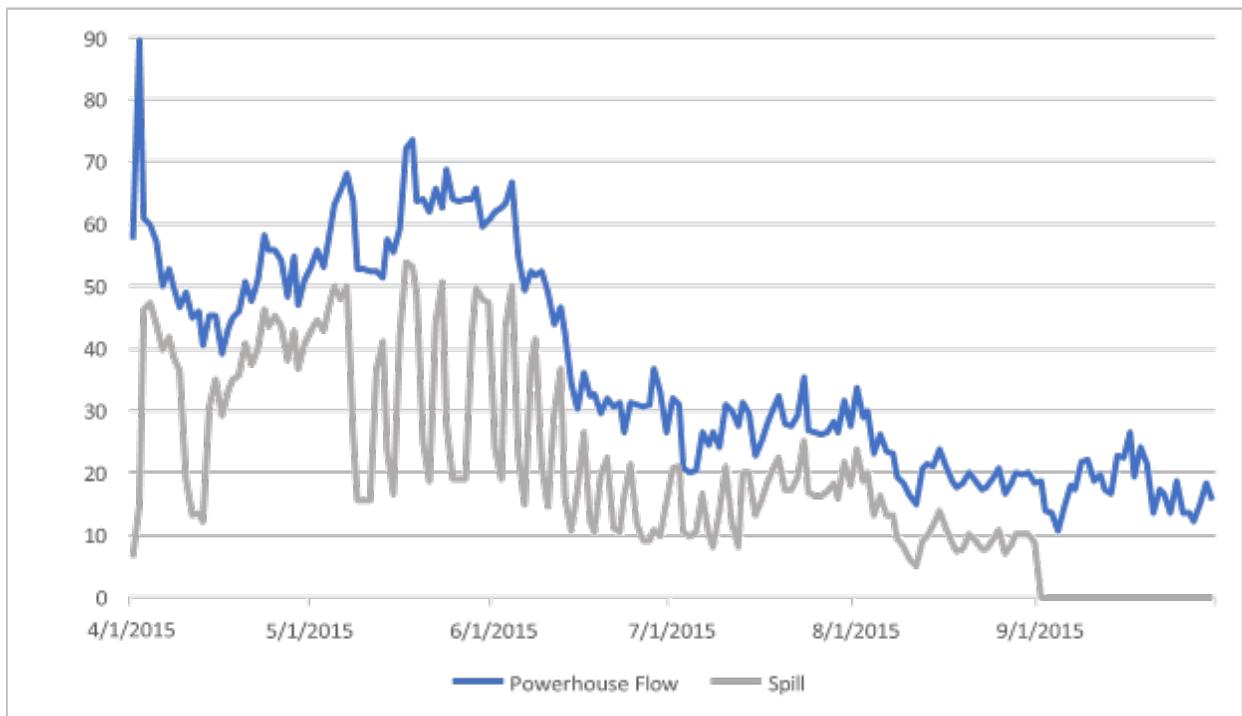
Figure 1. Comparison of daily project outflow and spill at Ice Harbor Dam, 2015.

The highest daily outflow for the season was on May 20 at 128.5 kilo cubic feet per second (kcfs). The lowest daily outflow for the season occurred on October 18 with an outflow of 16.9 kcfs. The average flow for the season was 54.6 kcfs, Figure 1. The highest spill was 74.6 on May 19 and the lowest spill above 0.0 occurred on September 16 at 0.07 kcfs. The average spill was 23.7 kcfs.

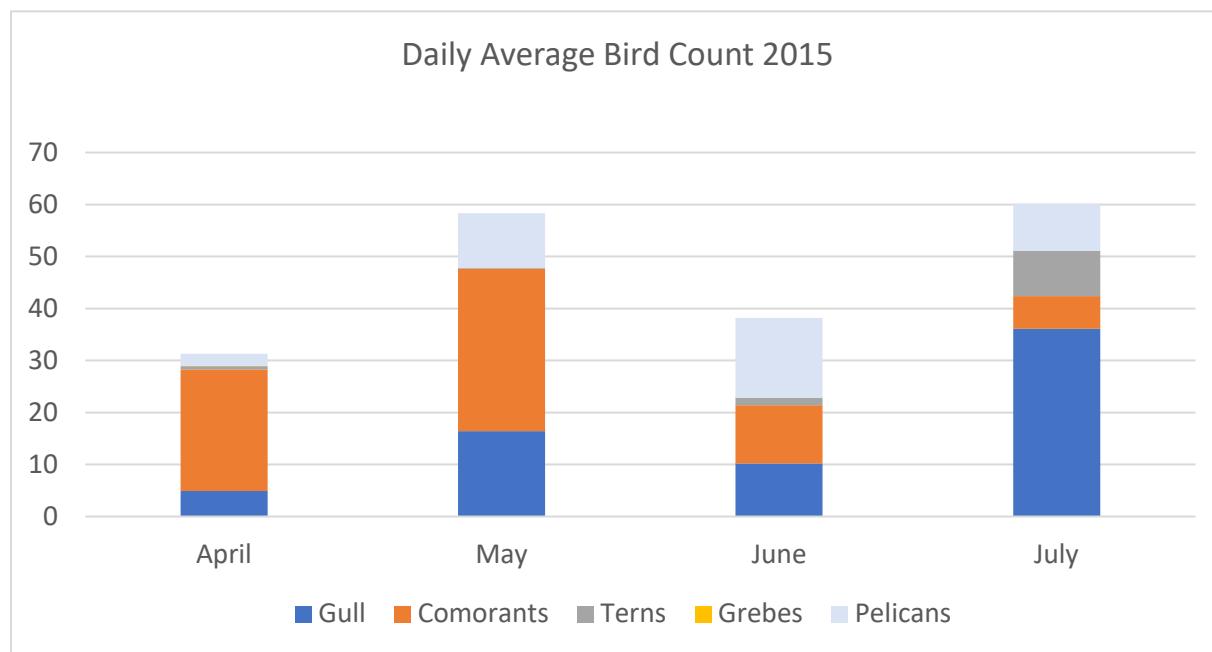
Figure 2. Average daily counts of avian predators by month at Ice Harbor, 2015.

From April 1 to July 31 the total monthly count of gulls varied. However, the highest number of birds observed from April 1 to the end of July peaked in the month of July (Figure 2). 1,120 gulls in total were observed for the month of July. The highest average daily count of gulls observed in a month occurred during July, totaling 120 on July 29. The lowest monthly total count of gulls was during April at 147.
