1. McNary

Project: Little Goose Dam

Biologist: Deb Snyder, Patricia Rozeboom
 Dates: November 29 – December 5, 2024

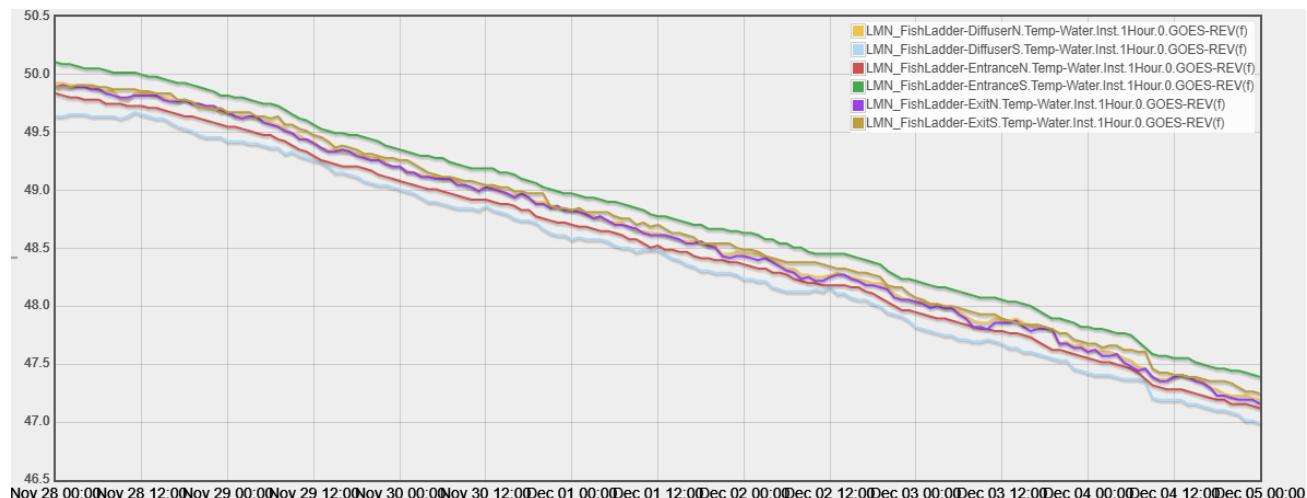
Temperature Probes: The adult passage temperature probes operated correctly during this reporting period.

The graph below shows the temperatures per recording point for the reporting period.
