1. McNary

Project: Little Goose Dam

Biologist: Deb Snyder, Patricia Rozeboom
 Dates: December 13 – December 19, 2024

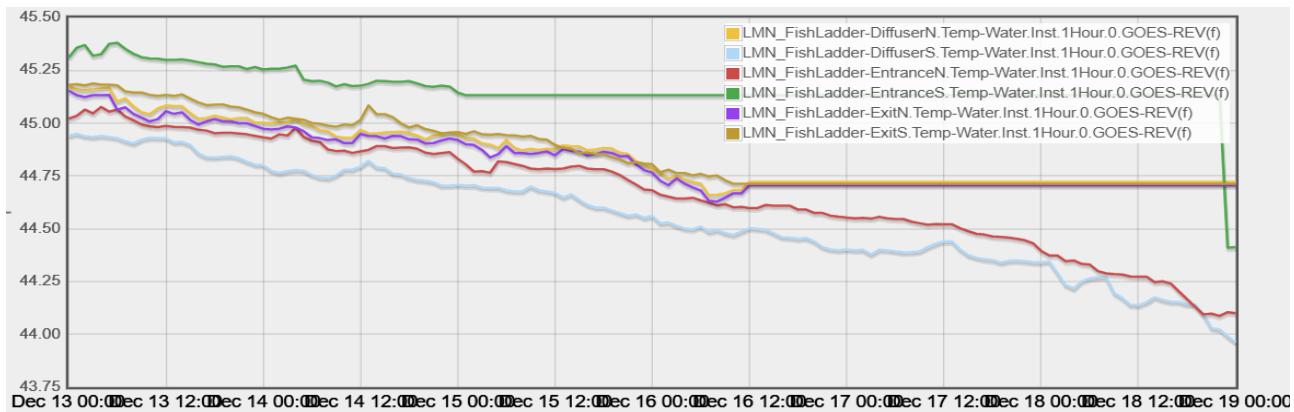
Temperature Probes: The adult passage temperature probes operated correctly during this reporting period.

The graph below shows the temperatures per recording point for the reporting period.
