MEMORANDUM FOR THE RECORD – 17 LGS 04 MFR Adult Steelhead Mortality**SUBJECT:** One dead steelhead found below primary dewaterer

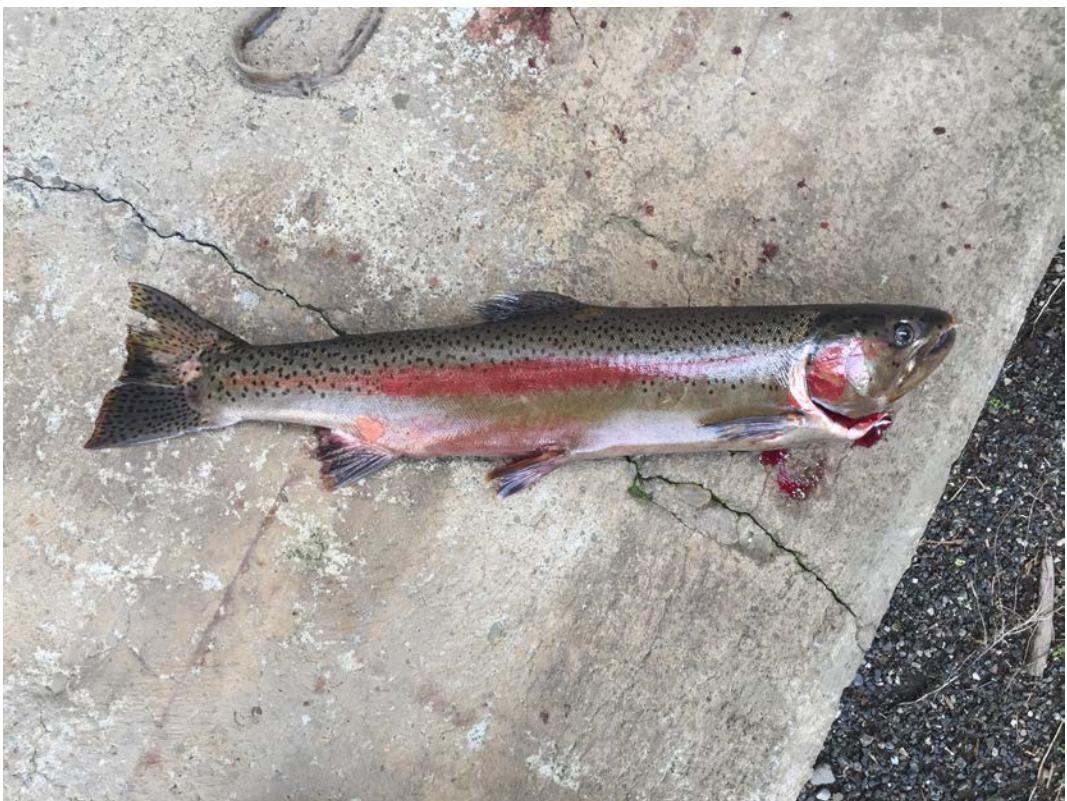
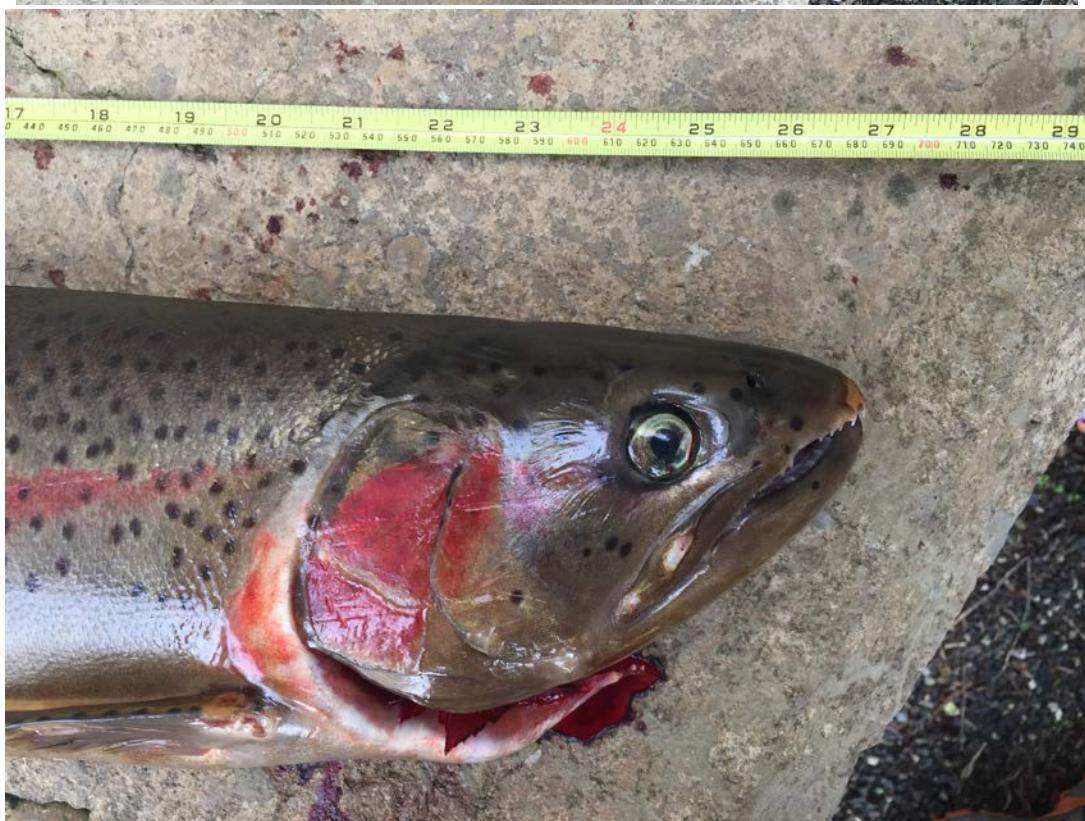
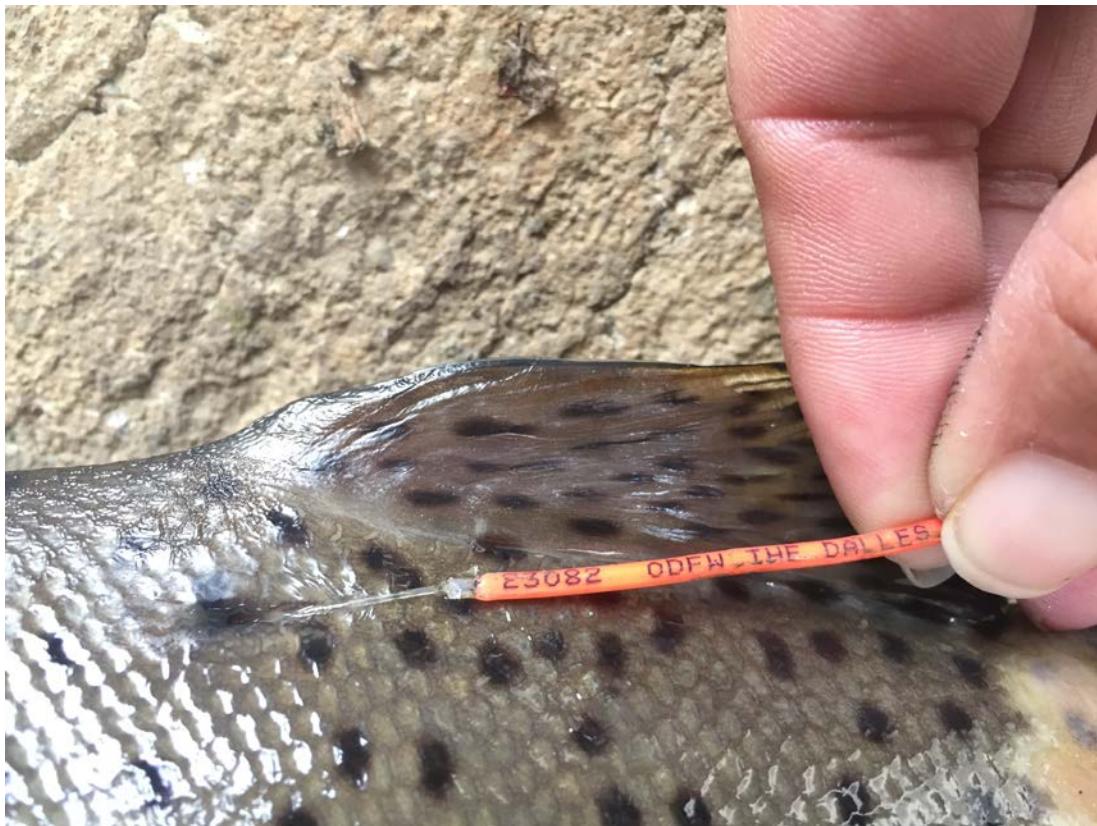
One adult steelhead was discovered on the ground below the primary dewaterer on 04/04/17. The adult steelhead was approximately 27", adipose clipped and marked with a floy tag, number 23082 from Oregon Department of Fish and Wildlife. The fish appeared to be in very good condition and likely died after jumping out of the fish ladder the morning of April 04.

- A. Species – Steelhead *Oncorhynchus mykiss*
- B. Origin – Hatchery
- C. Length – 27"
- D. Marks and tags – Adipose clip, Floy Tag-23082 ODFW The Dalles
- E. Marks and Injuries found on carcass – None
- F. Cause and Time of Death – Fish likely jumped outside the ladder structure in an elevated section near the primary dewaterer on morning of April 04.
- G. Future and Preventative Measures – Further efforts are underway to determine the location and necessity of netting to prevent future mortalities.

Post Investigation Report: After further investigation, it was determined that the adult steelhead jumped out of the dewatering structure. Daily operations for removing debris out of the dewatering structure have been modified to reduce the likelihood of spooking adults, causing them to jump. Additionally, placement of netting material to prevent future mortality will be discussed and implementation could occur during the next winter maintenance outage.
